777

Service Bulletin

Number: 777-53A0075
Original Issue: January 14, 2015
Revision 1: December 14, 2015
ATA System: 5380

SUBJECT: FUSELAGE - Section 48 - Station 2370 Pivot Bulkhead Forward Outer Chord -
Inspection and Repair

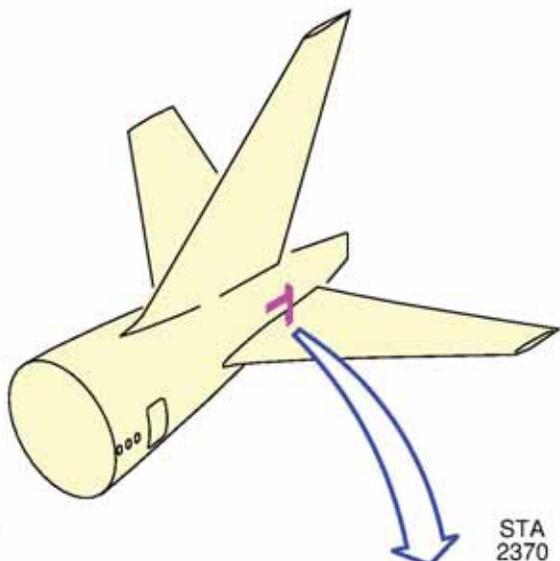
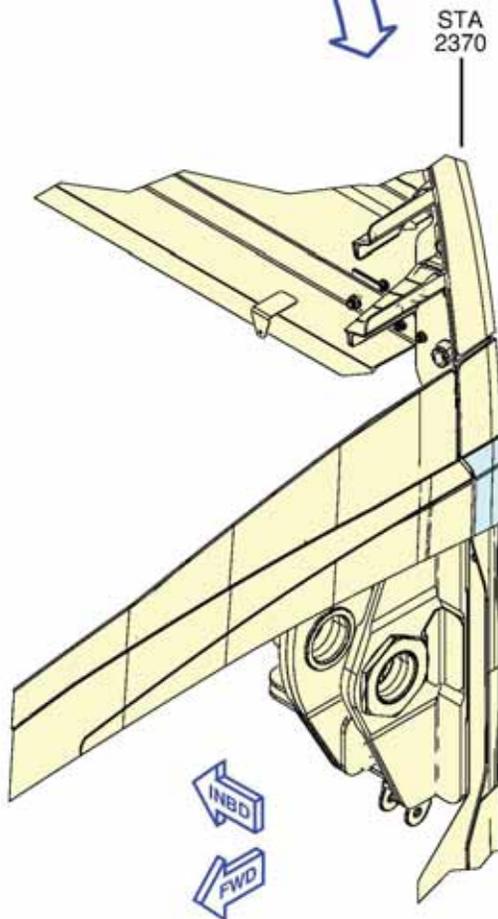
LEFT AND RIGHT SIDE:
 DO A DETAILED AND HFEC INSPECTION OF THE STATION 2370 PIVOT BULKHEAD FORWARD CHORD IN ACCORDANCE WITH PART 1, FOR ANY CRACK. IF ANY CRACK IS FOUND, AND NO CRACK FOUND IS GREATER THAN 0.160 INCH, DO ONE OF THE FOLLOWING OPTIONS ON THE AFFECTED SIDE OF THE AIRPLANE:

IF ANY CRACK FOUND IS GREATER THAN 0.160 INCH, DO THE TERMINATING ACTION IN ACCORDANCE WITH SB 777-53-0076.
 IF NO CRACK IS FOUND, REPEAT PART 1, OR DO THE TERMINATING ACTION IN ACCORDANCE WITH SB 777-53-0076.

1. DO THE TERMINATING ACTION IN ACCORDANCE WITH SB 777-53-0076.
2. DO THE REPAIR OF THE STATION 2370 PIVOT BULKHEAD FORWARD CHORD IN ACCORDANCE WITH PART 2, AND THE POST-REPAIR DETAILED AND HFEC INSPECTION IN ACCORDANCE WITH PART 3.

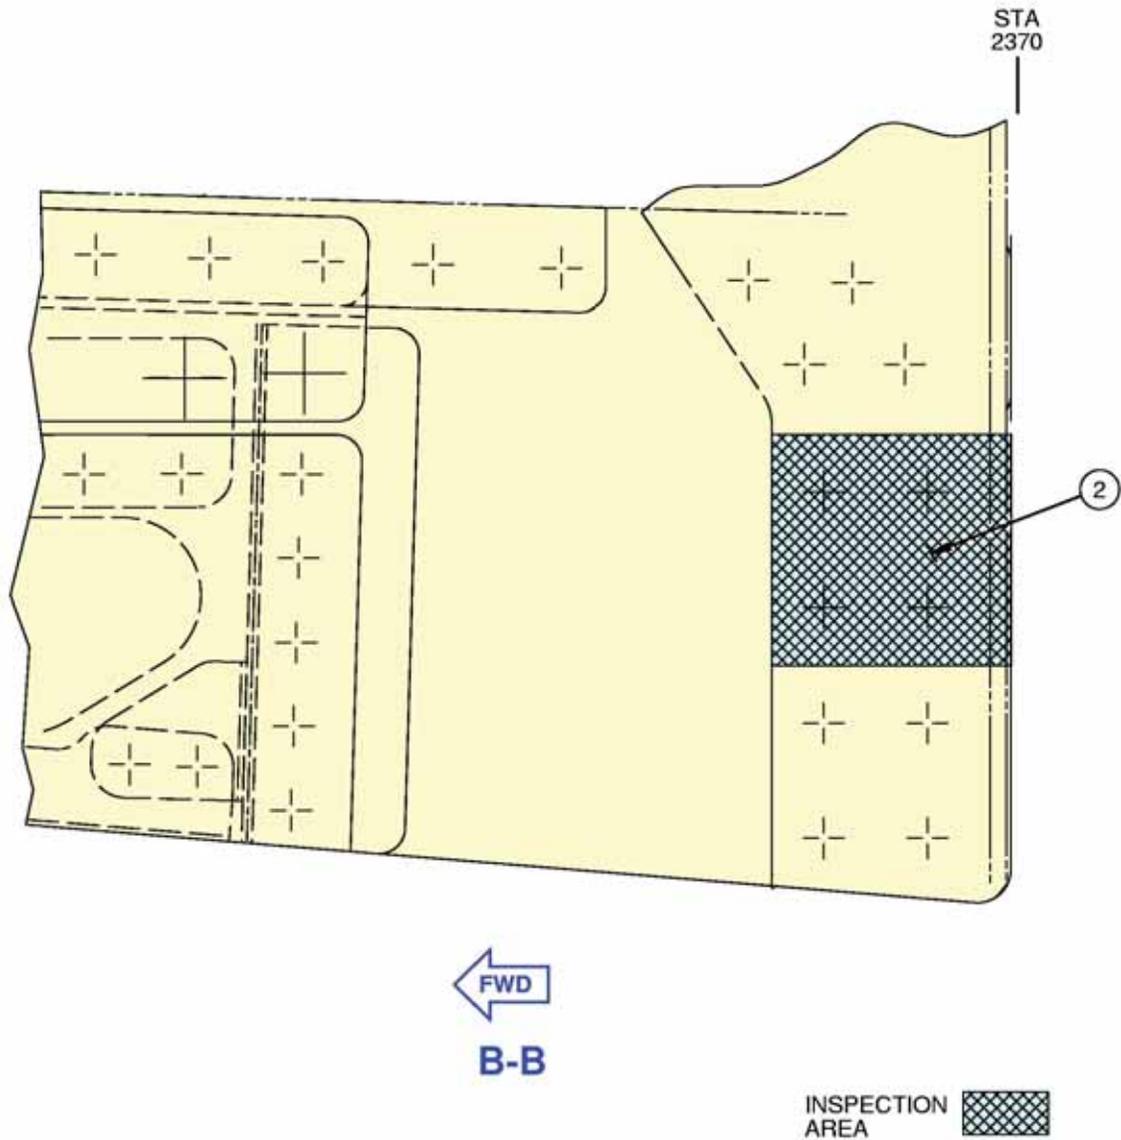
Step	Task	Name	Identification	Qty	More Data
1	Inspect	CHORD - FORWARD, PIVOT BULKHEAD, MID	148W7102-()	1	Do a DET for any crack.
