777

Service Bulletin

Number: 777-53A0075
Original Issue: January 14, 2015
Revision 1: December 14, 2015
ATA System: 5380

SUBJECT: FUSELAGE - Section 48 - Station 2370 Pivot Bulkhead Forward Outer Chord -
Inspection and Repair

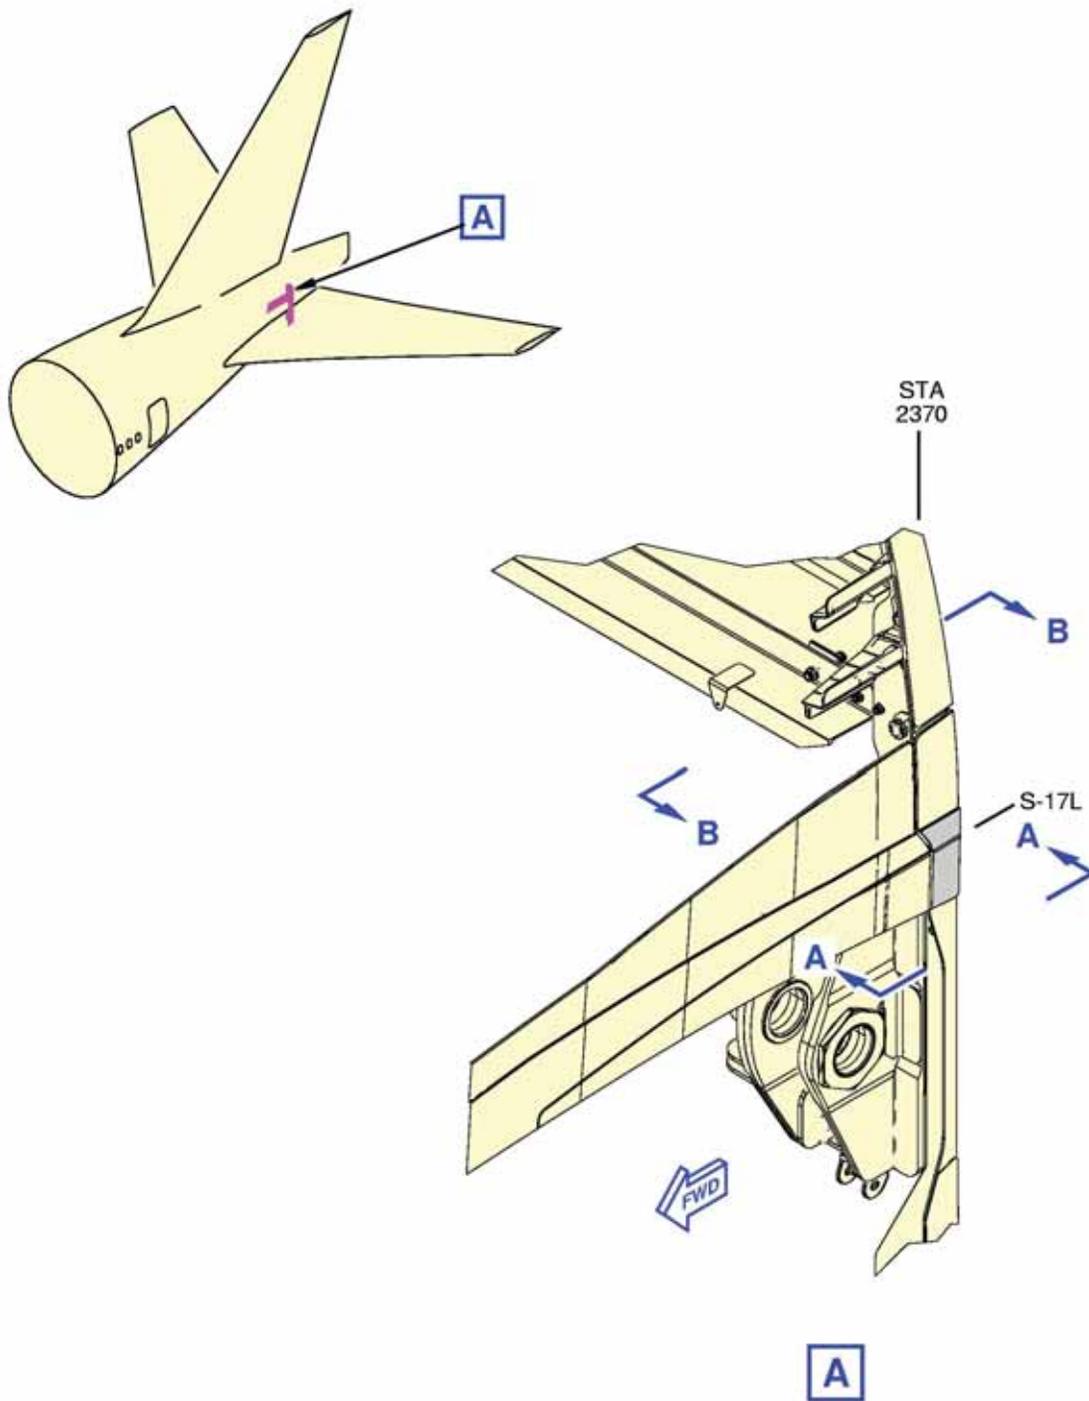
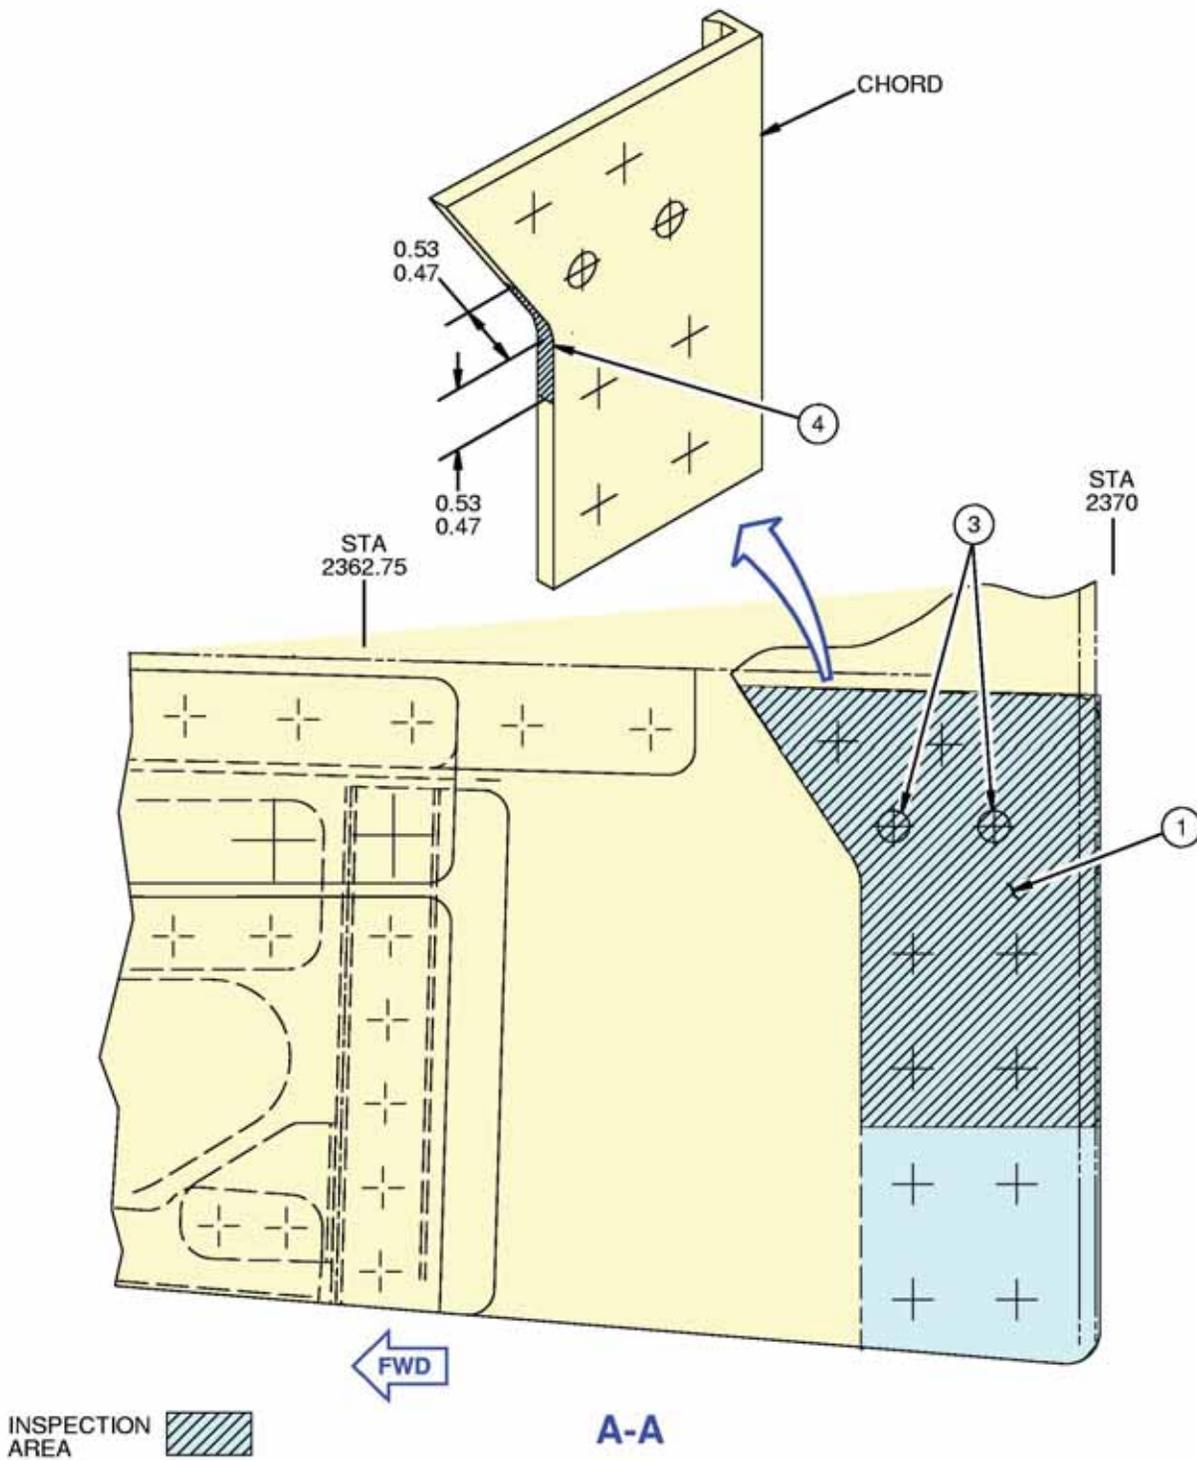
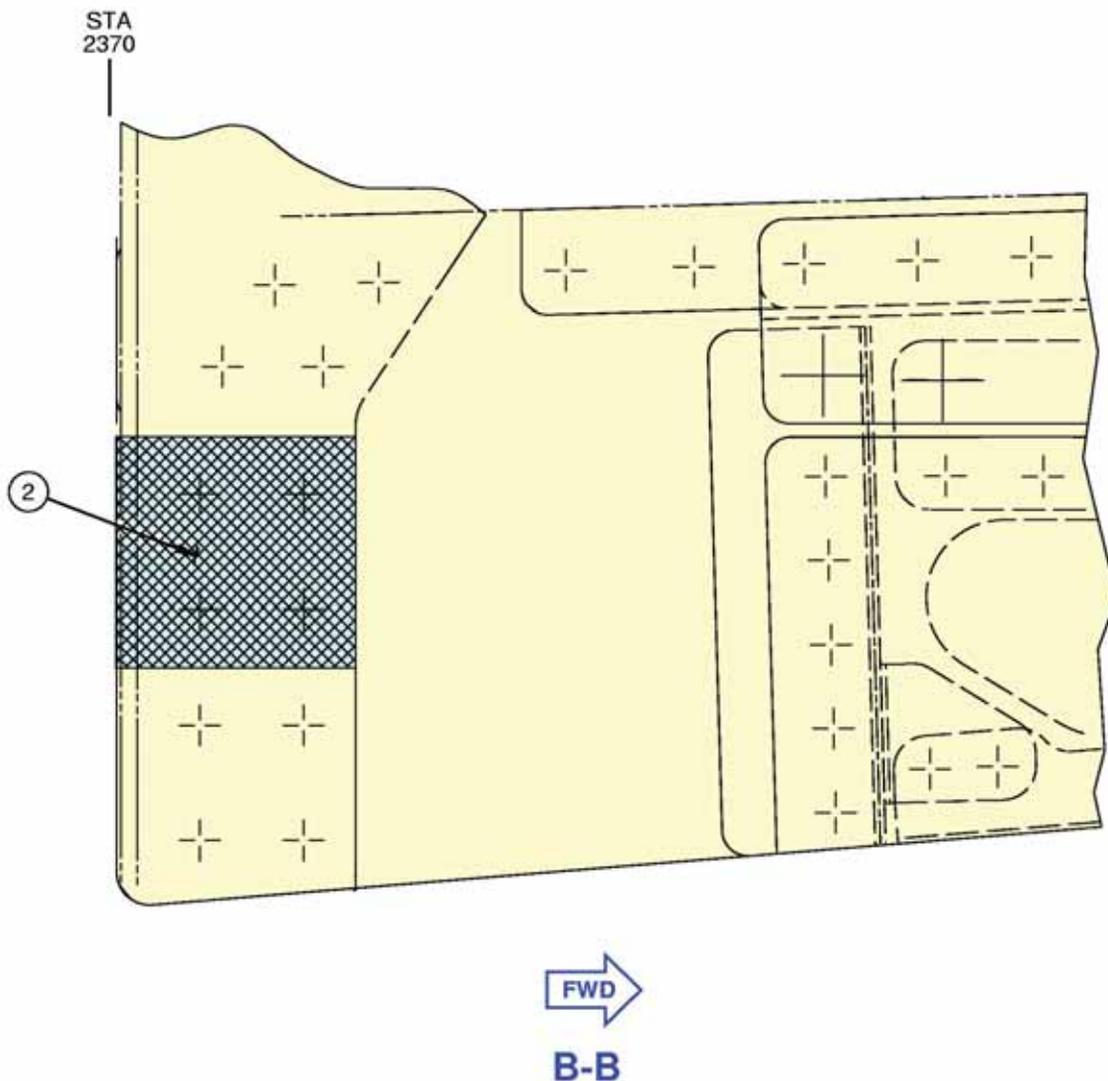
FIGURE 3: LEFT SIDE - STA 2370 PIVOT BULKHEAD FORWARD OUTER CHORD - DET AND HFEC INSPECTION (SHEET 1 OF 4)

Step	Task	Name	Identification	Qty	More Data
1	Inspect	CHORD - FORWARD, PIVOT BULKHEAD, MID	148W7102-()	1	Do a DET for any crack.

Step	Task	Name	Identification	Qty	More Data
2	Inspect	CHORD - FORWARD, PIVOT BULKHEAD, MID	148W7102-()	1	Do a DET for any crack.
3	Inspect	CHORD - FORWARD, PIVOT BULKHEAD, MID	148W7102-()	1	Do an open hole HFEC inspection for any crack, in accordance with 777 NDT Manual Part 6, 51-00-02.
4	Inspect	CHORD - FORWARD, PIVOT BULKHEAD, MID	148W7102-()	1	Do a surface HFEC inspection for any crack, in accordance with 777 NDT Manual Part 6, 51-00-01.

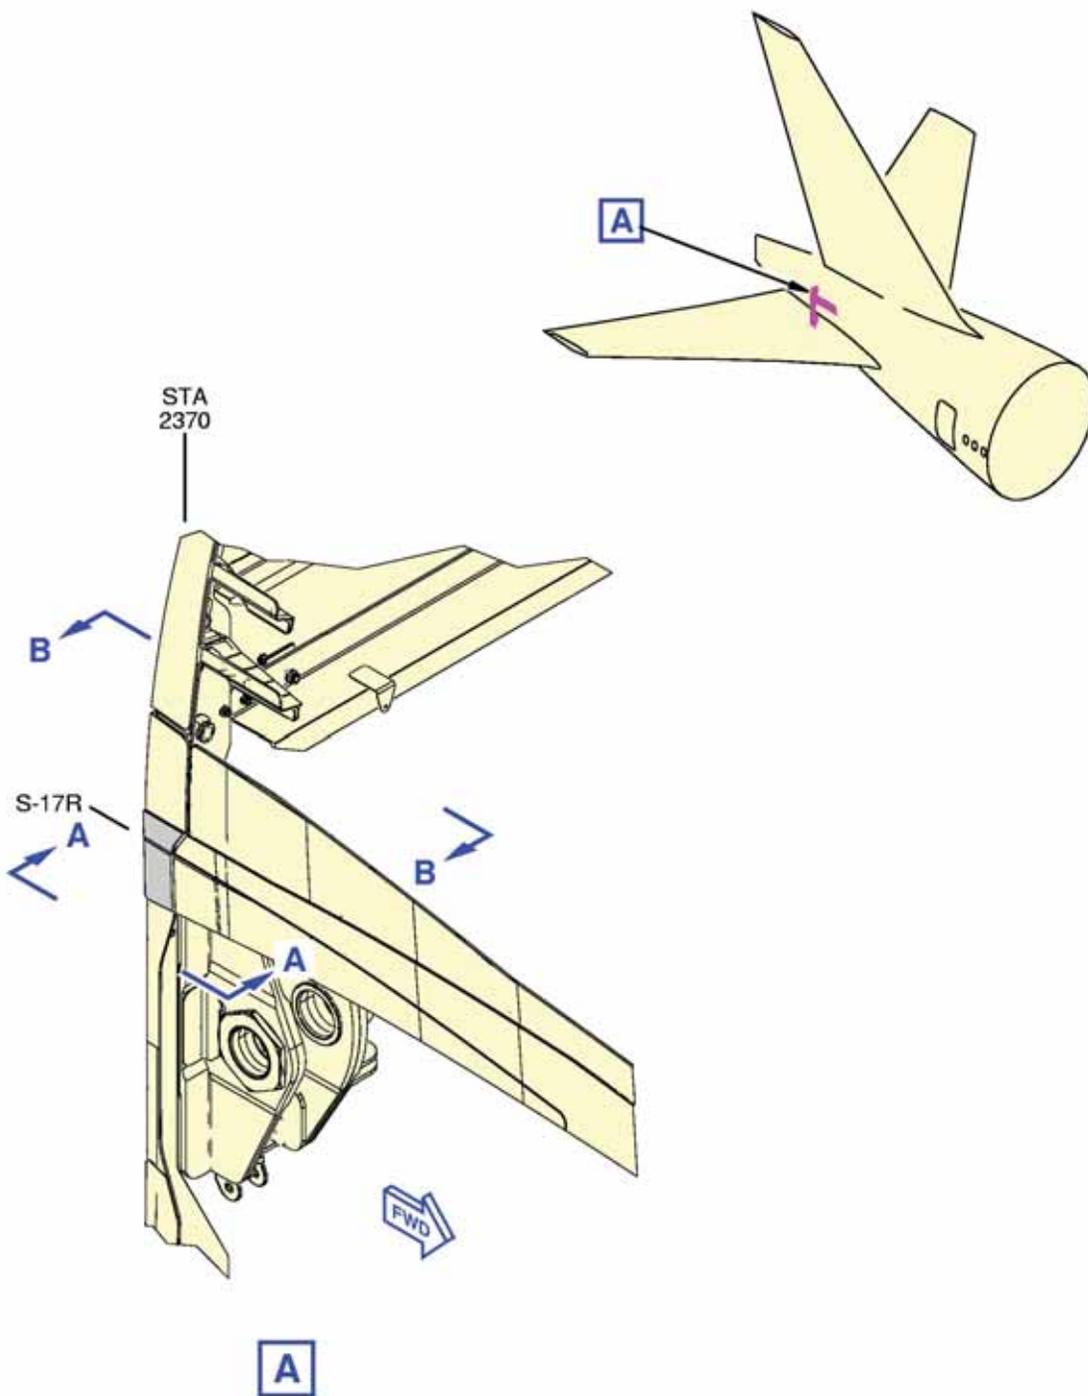
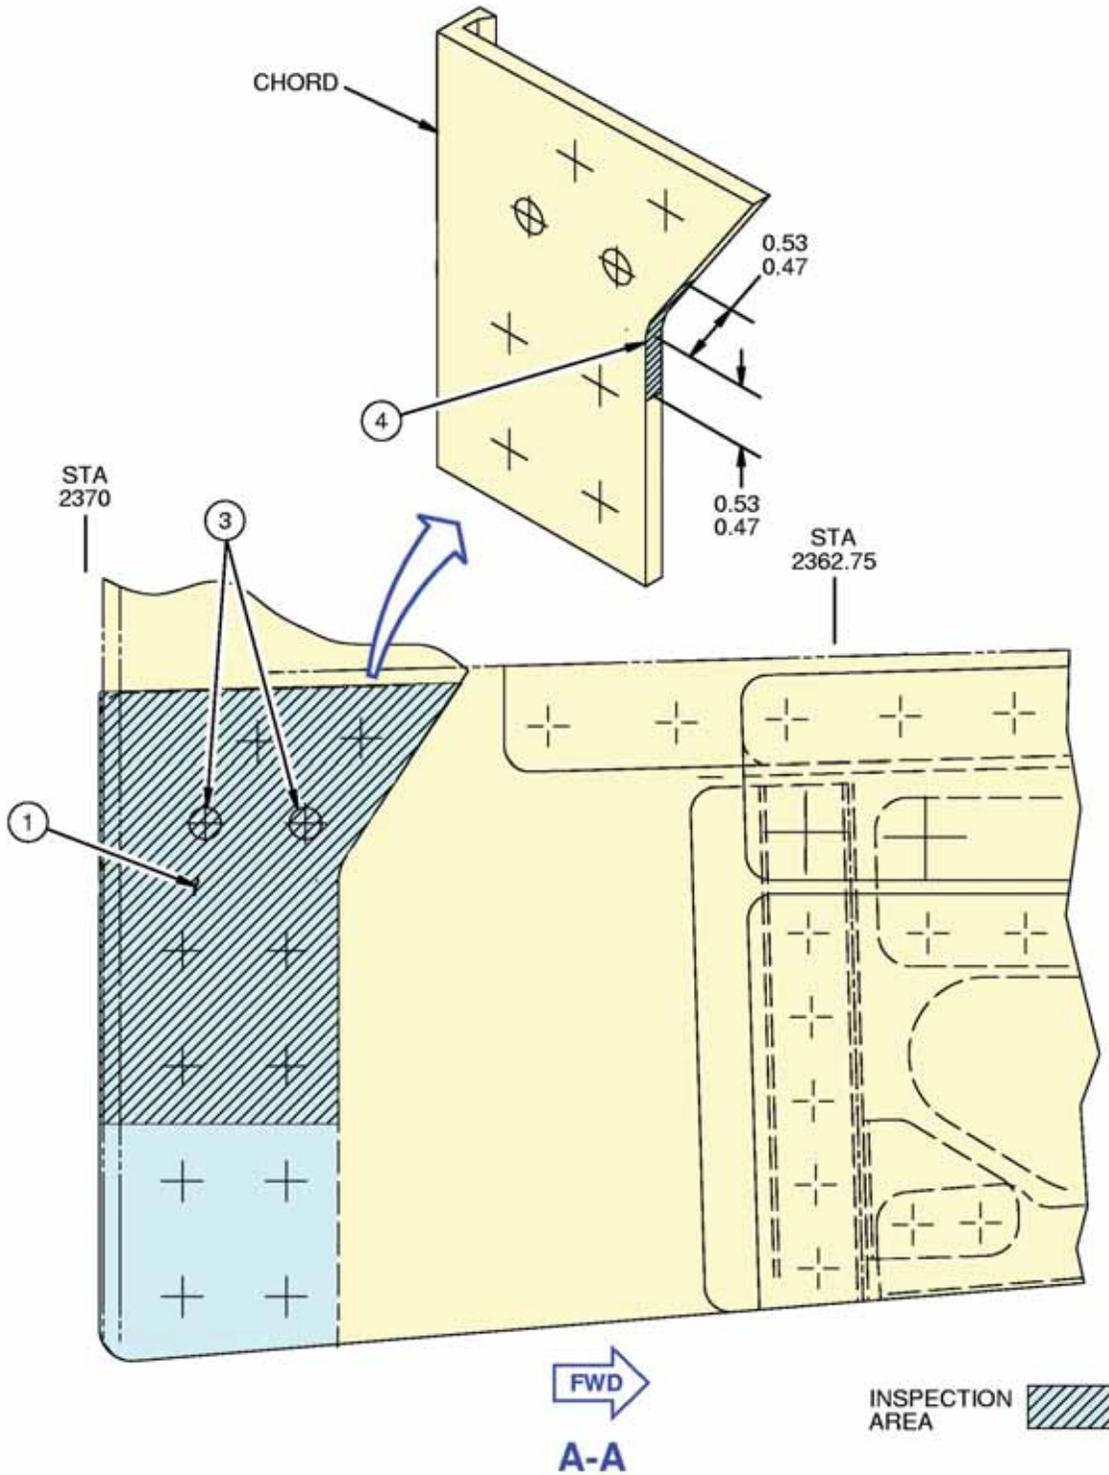
FIGURE 4: RIGHT SIDE - STA 2370 PIVOT BULKHEAD FORWARD OUTER CHORD - DET AND HFEC INSPECTION (SHEET 1 OF 4)

Step	Task	Name	Identification	Qty	More Data
1	Inspect	CHORD - FORWARD, PIVOT BULKHEAD, MID	148W7102-()	1	Do a DET for any crack.

Step	Task	Name	Identification	Qty	More Data
2	Inspect	CHORD - FORWARD, PIVOT BULKHEAD, MID	148W7102-()	1	Do a DET for any crack.
3	Inspect	CHORD - FORWARD, PIVOT BULKHEAD, MID	148W7102-()	1	Do an open hole HFEC inspection for any crack, in accordance with 777 NDT Manual Part 6, 51-00-02.
4	Inspect	CHORD - FORWARD, PIVOT BULKHEAD, MID	148W7102-()	1	Do a surface HFEC inspection for any crack, in accordance with 777 NDT Manual Part 6, 51-00-01.

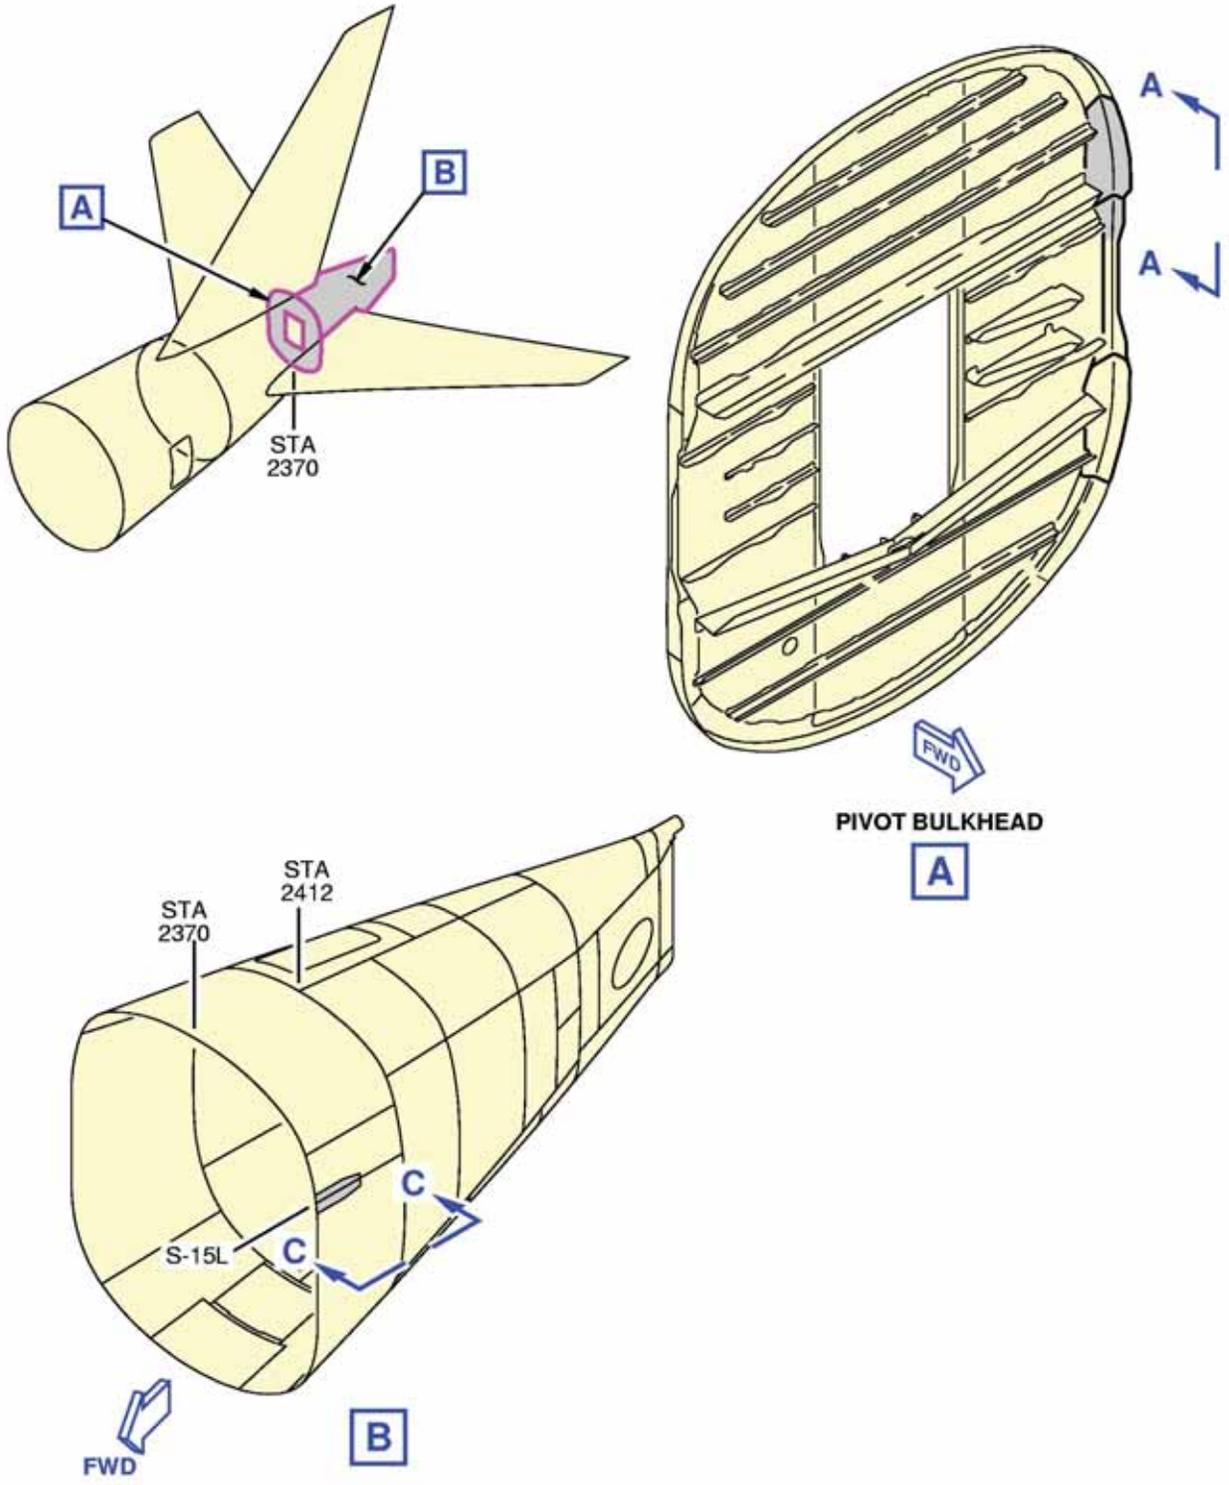
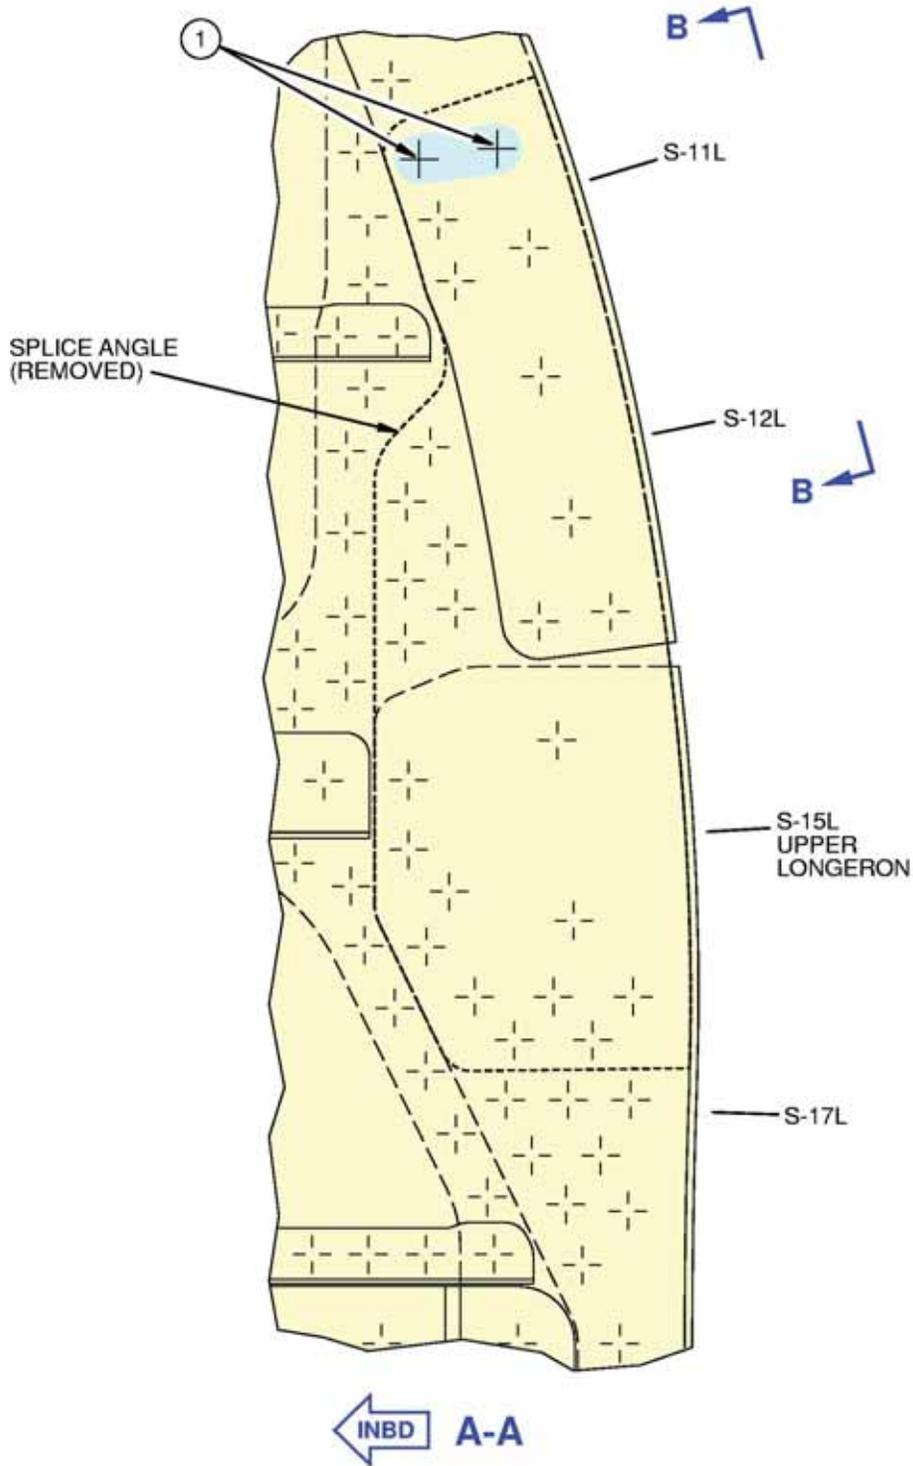
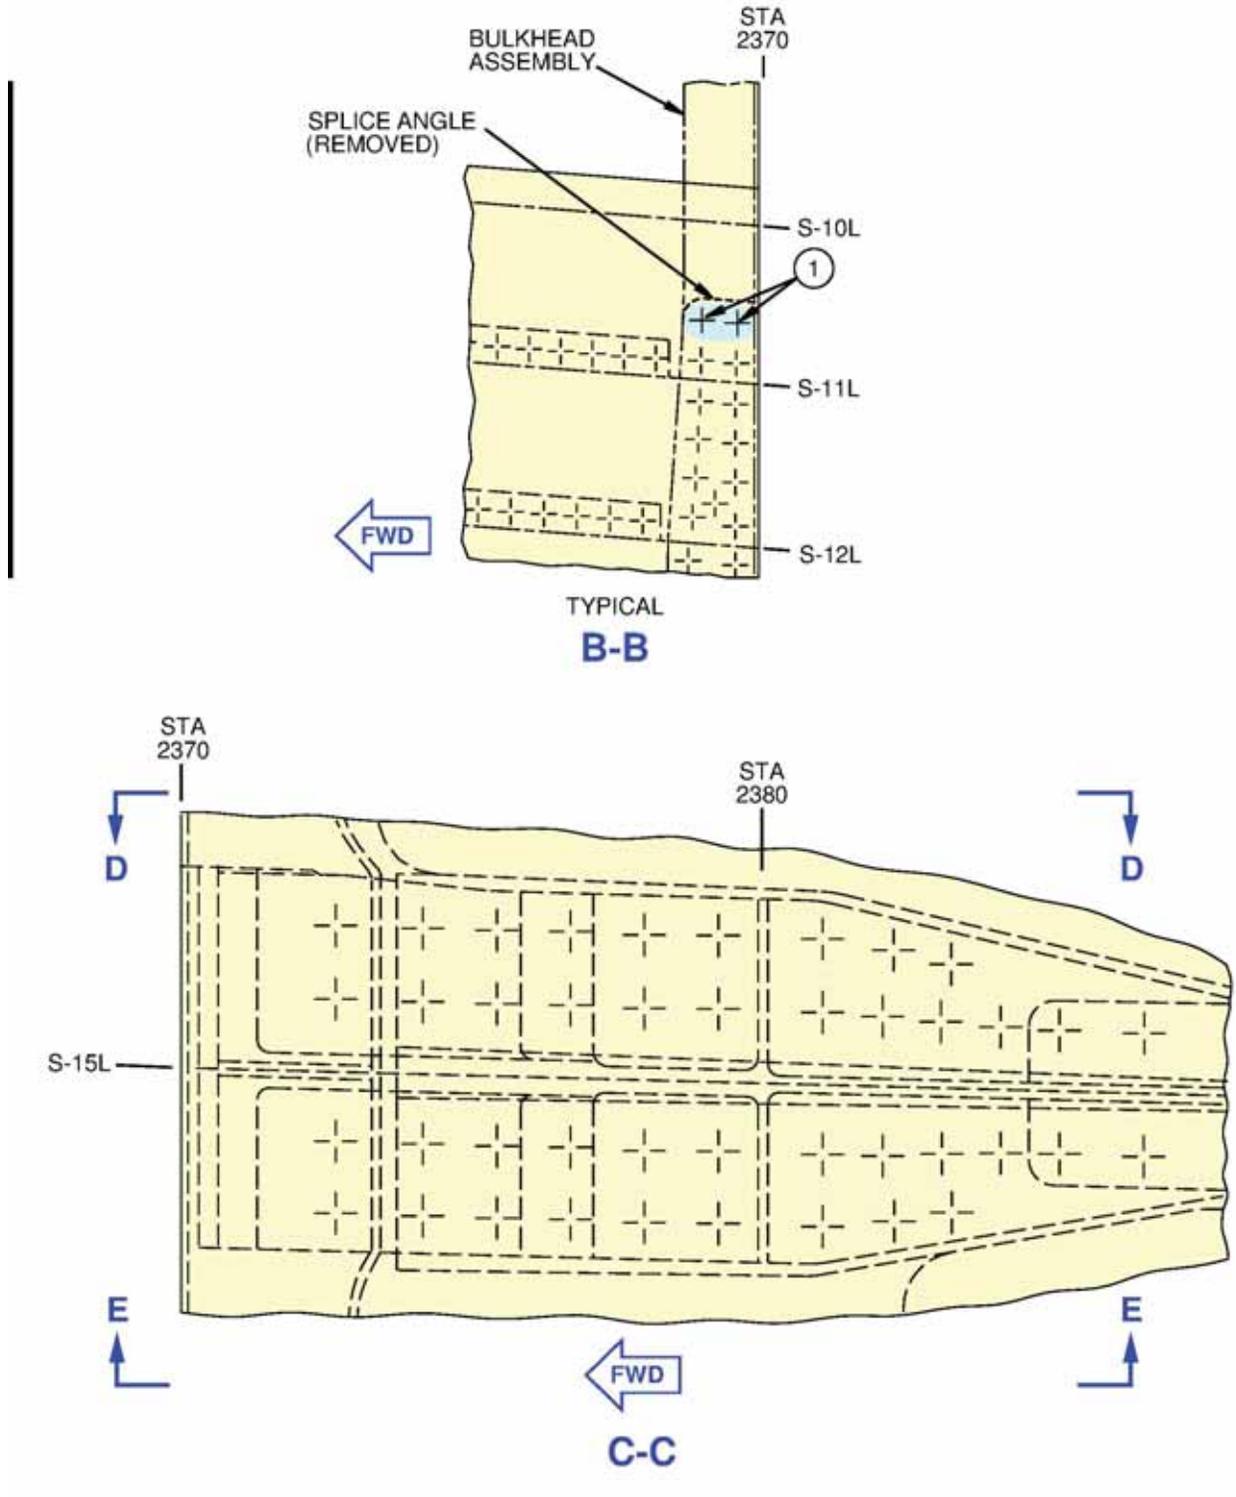
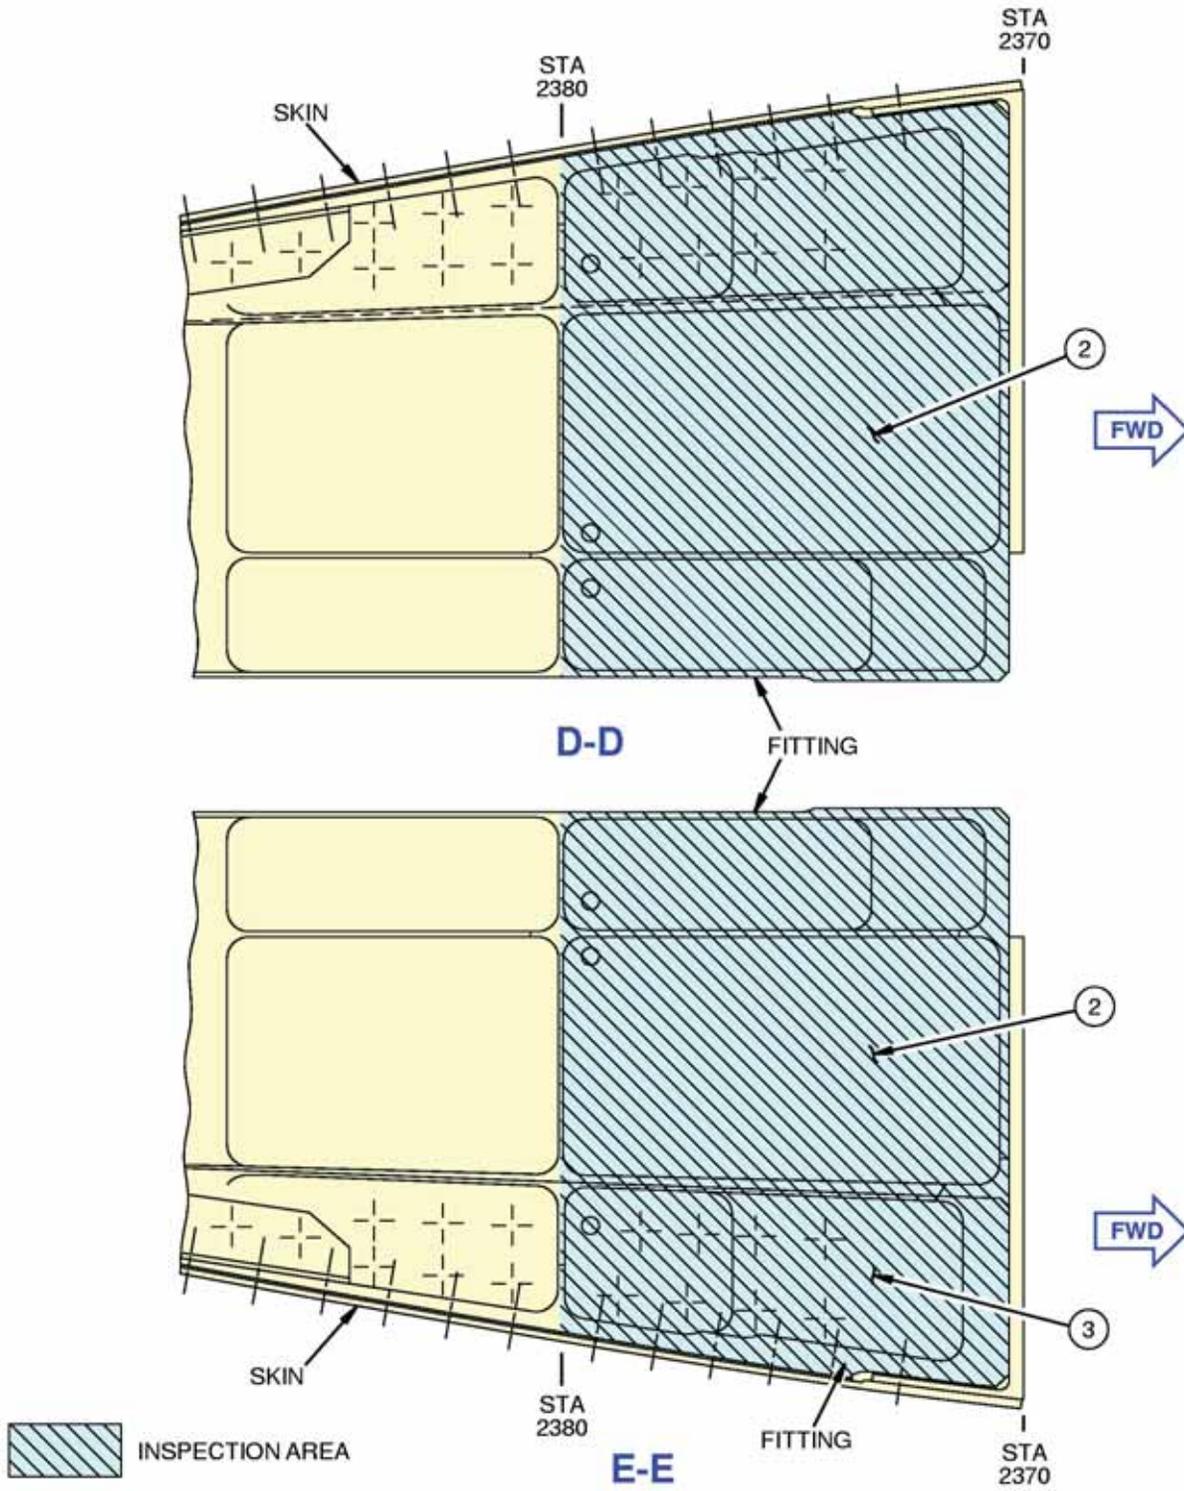
FIGURE 11: LEFT SIDE - STA 2370 PIVOT BULKHEAD FORWARD OUTER CHORD AND ADJACENT STRUCTURE - HFEC AND DET INSPECTION (SHEET 1 OF 5)

Step	Task	Name	Identification	Qty	More Data
1	Inspect	HOLE	-	4	Do an open hole High Frequency Eddy Current (HFEC) inspection for any crack, of the holes common to the pivot bulkhead web, the upper forward chord and the aft chord, and of the holes common to the skin and the bulkhead assembly, in accordance with 777 NDT Manual Part 6, 51-00-02.
2	Inspect	FITTING	148W5126-()	1	Do a Detailed Inspection (DET) of the upper aft longeron extension fittings between STA 2370 and STA 2380, for any crack.
3	Inspect	FITTING	148W5127-()	1	Do a Detailed Inspection (DET) of the upper aft longeron extension fittings between STA 2370 and STA 2380, for any crack.

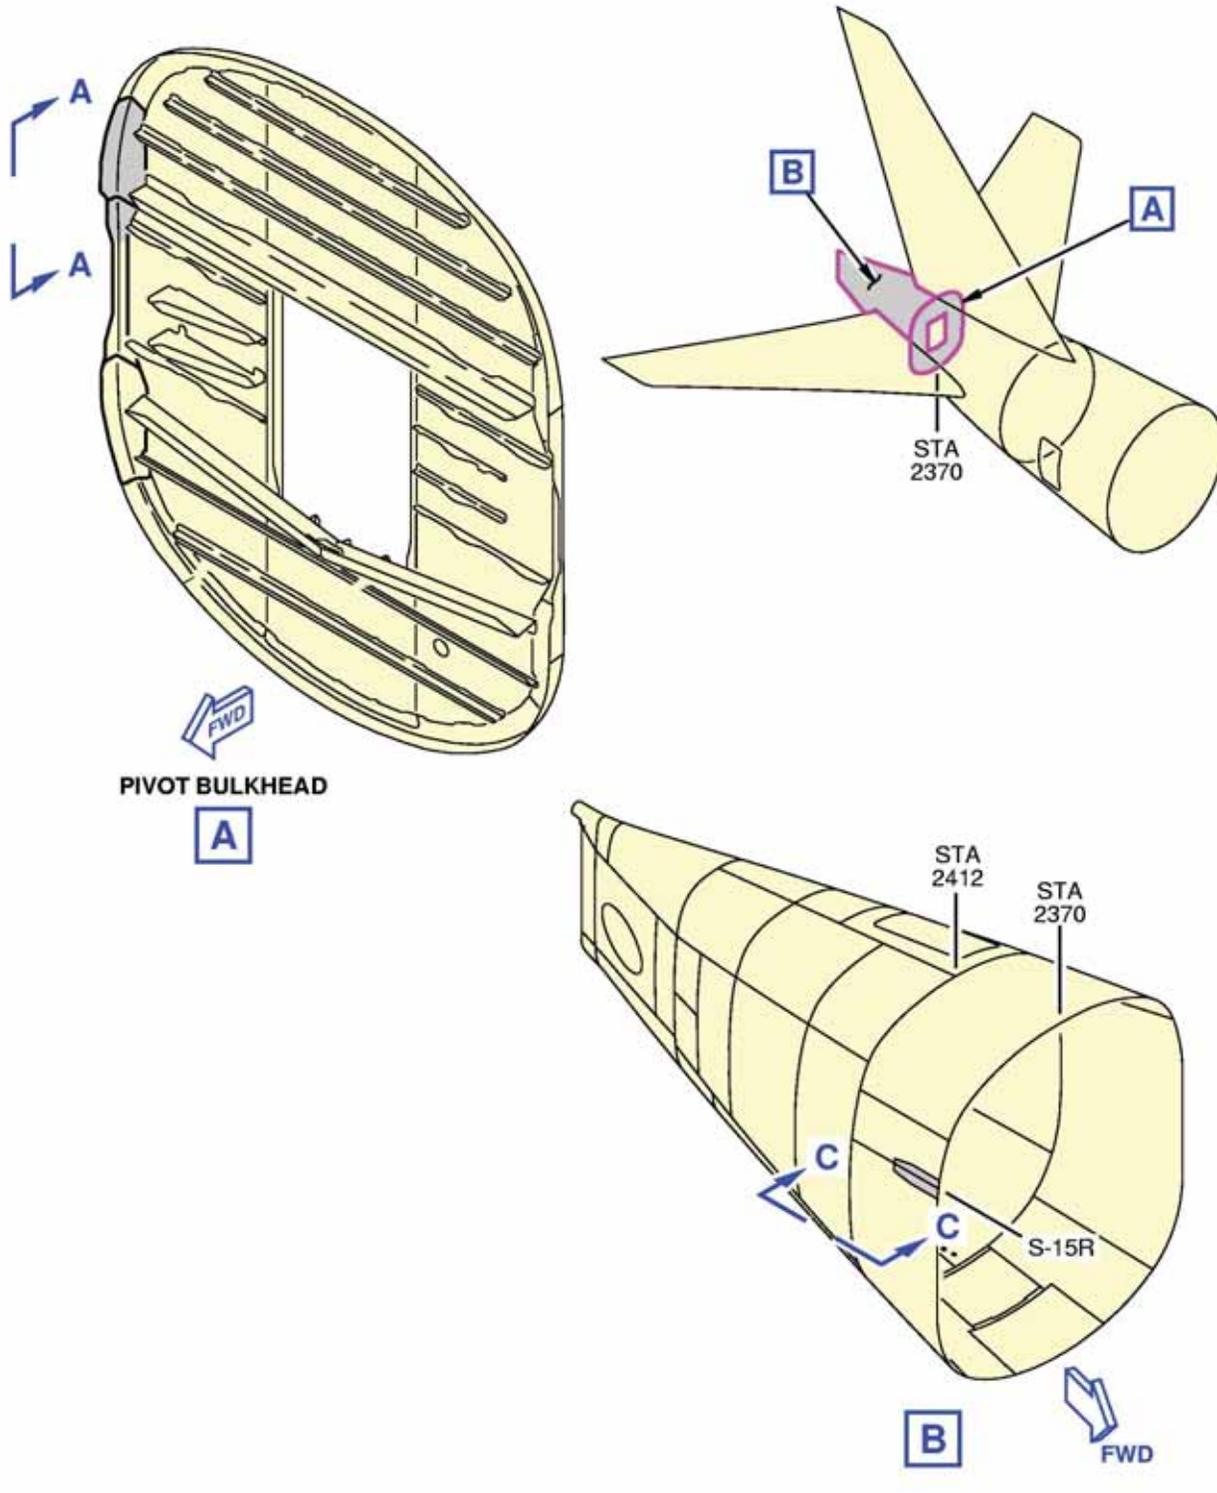
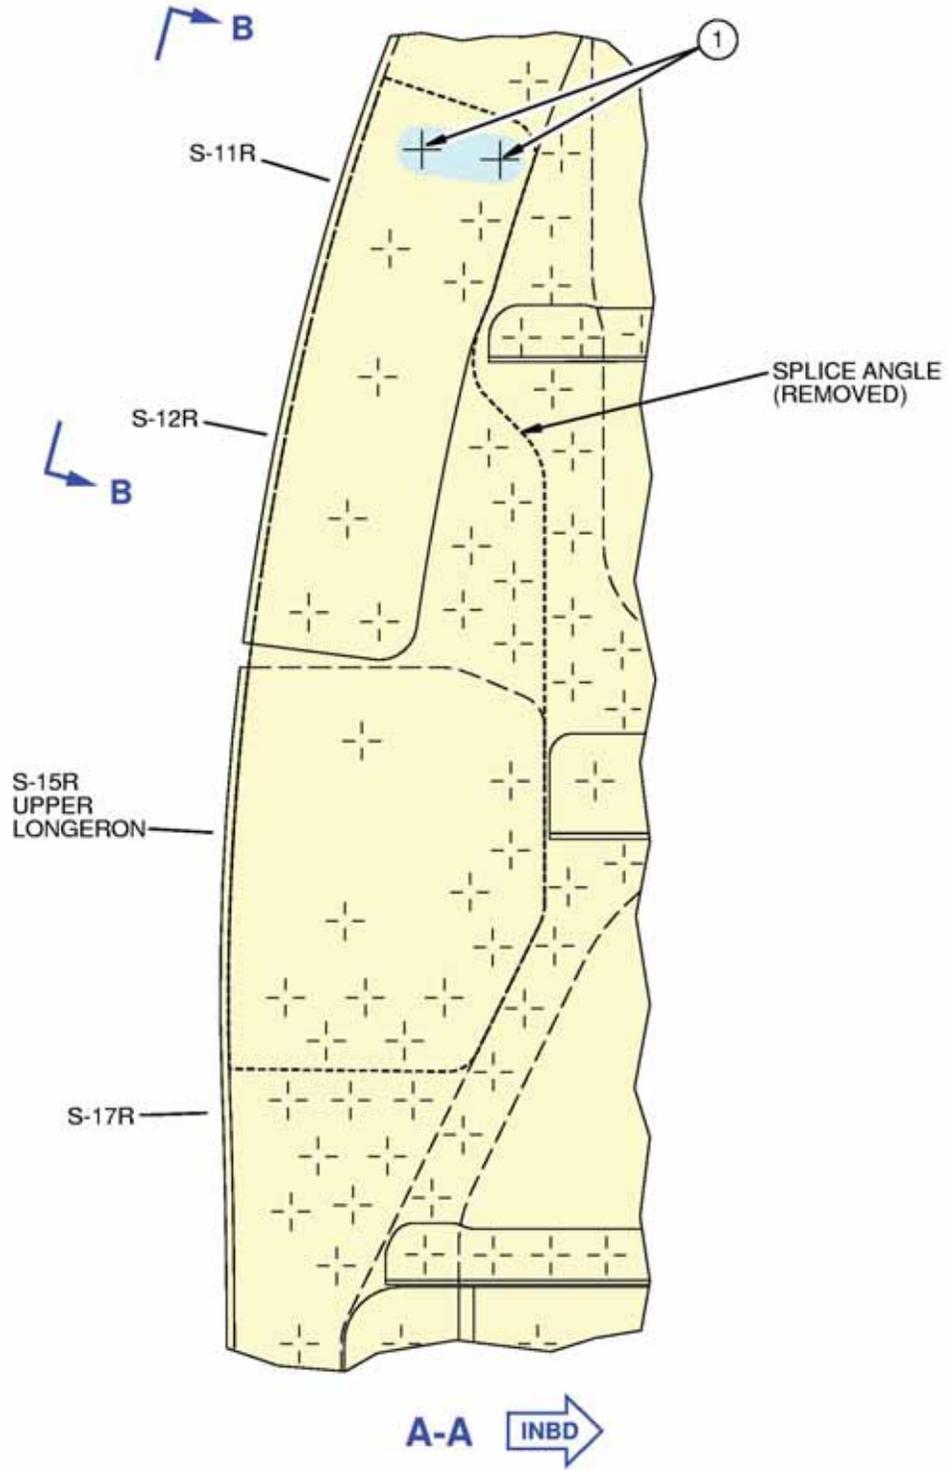
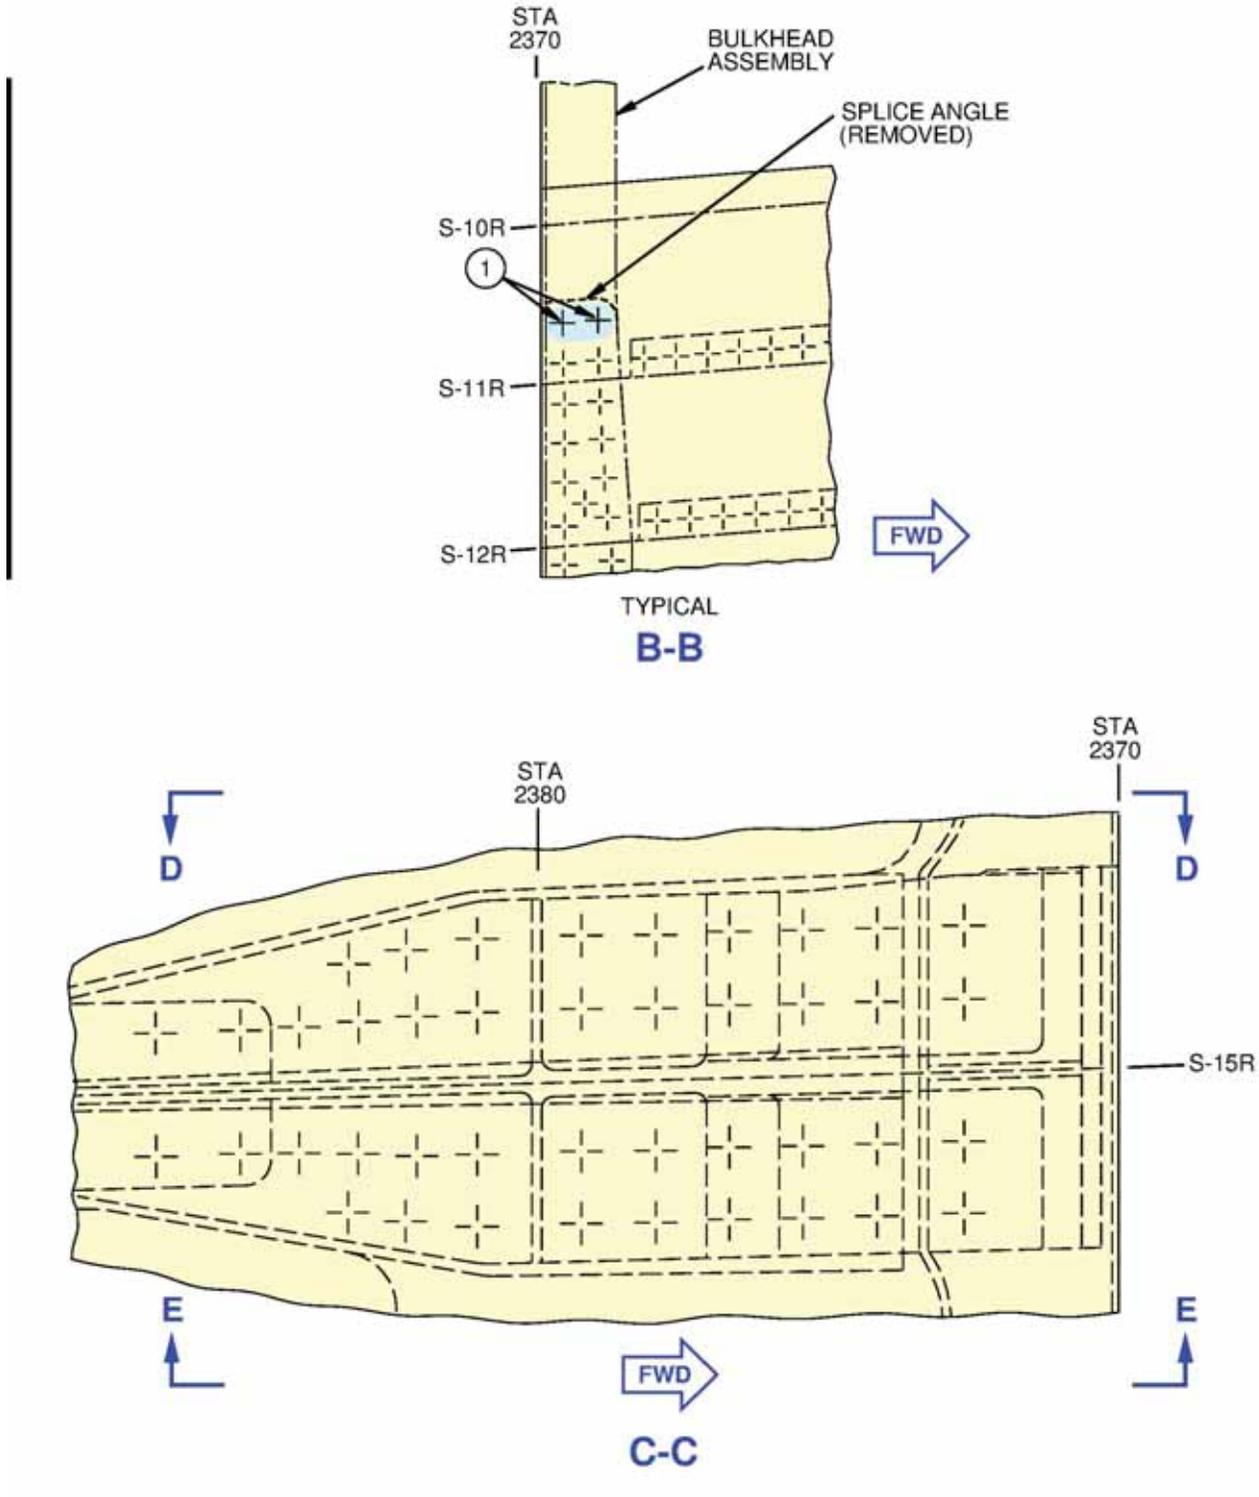
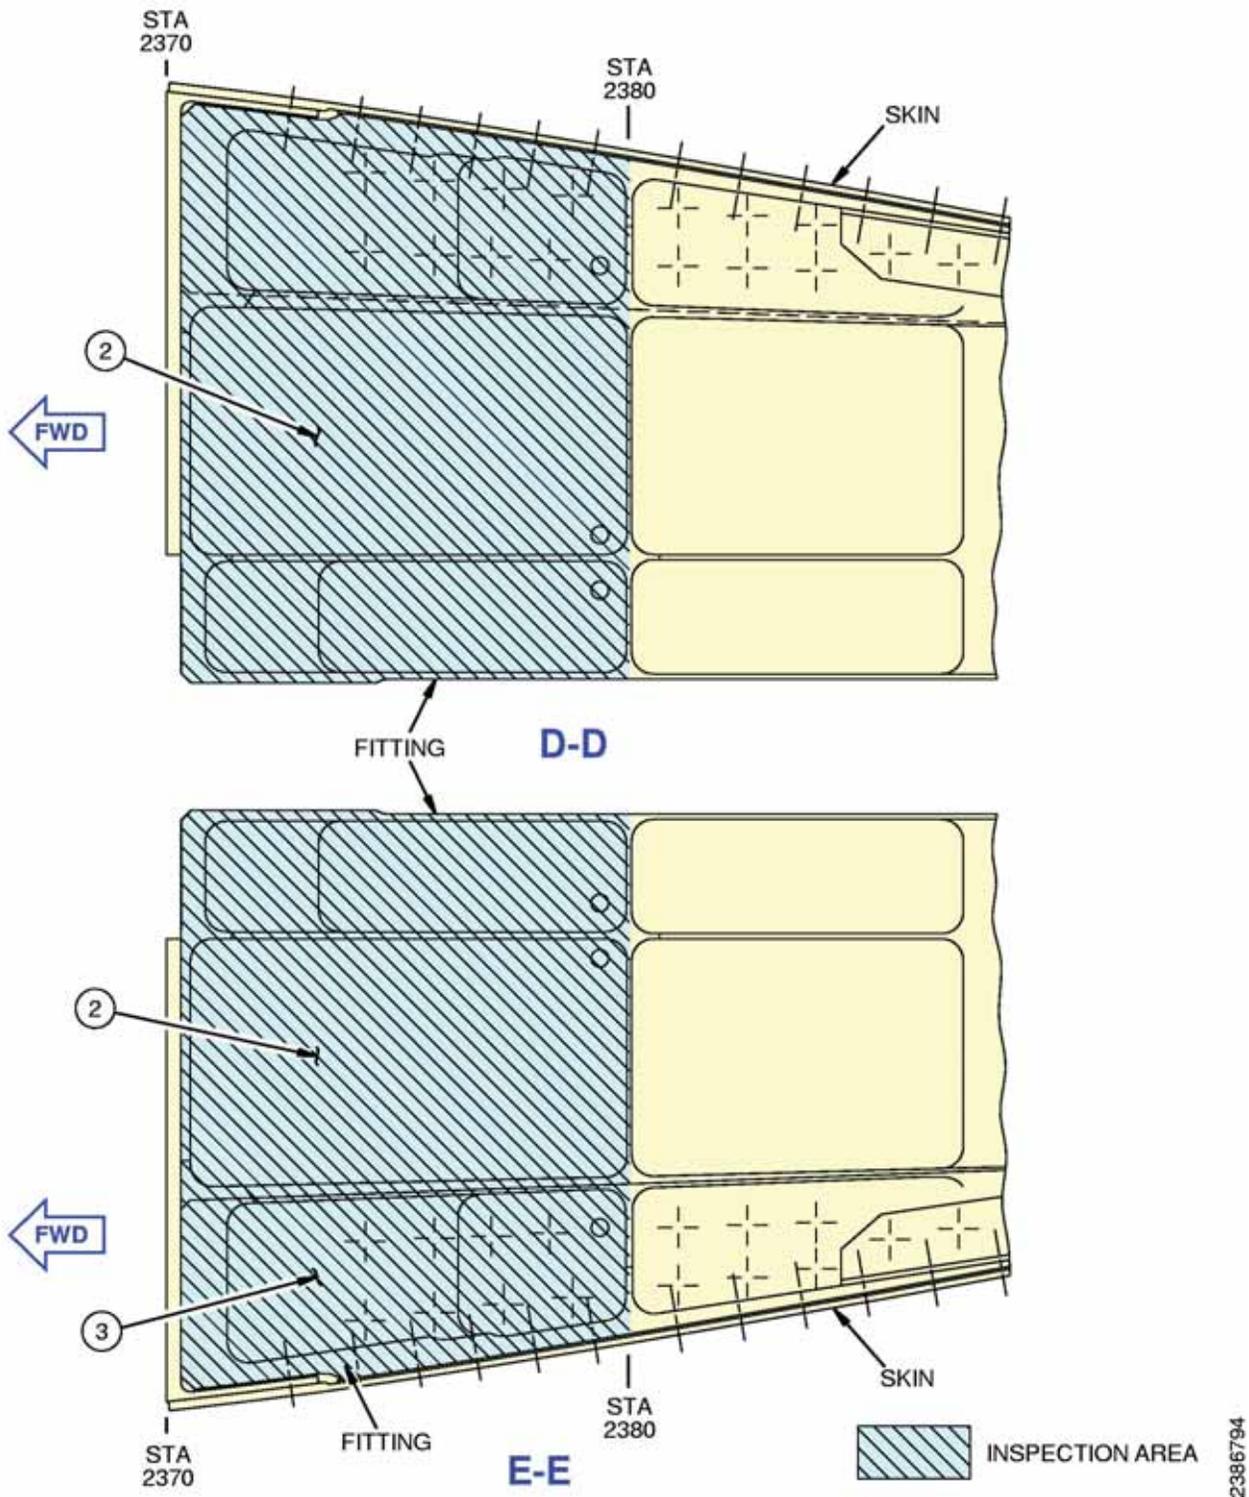
FIGURE 12: RIGHT SIDE - STA 2370 PIVOT BULKHEAD FORWARD OUTER CHORD AND ADJACENT STRUCTURE - HFEC AND DET INSPECTION (SHEET 1 OF 5)

Step	Task	Name	Identification	Qty	More Data
1	Inspect	HOLE	-	4	Do an open hole High Frequency Eddy Current (HFEC) inspection for any crack, of the holes common to the pivot bulkhead web, the upper forward chord and the aft chord, and of the holes common to the skin and the bulkhead assembly, in accordance with 777 NDT Manual Part 6, 51-00-02.
2	Inspect	FITTING	148W5126-()	1	Do a Detailed Inspection (DET) of the upper aft longeron extension fittings between STA 2370 and STA 2380, for any crack.
3	Inspect	FITTING	148W5127-()	1	Do a Detailed Inspection (DET) of the upper aft longeron extension fittings between STA 2370 and STA 2380, for any crack.
