777

Service Bulletin

Number: 777-53A0075
Original Issue: January 14, 2015
Revision 1: December 14, 2015
ATA System: 5380

SUBJECT: FUSELAGE - Section 48 - Station 2370 Pivot Bulkhead Forward Outer Chord -
Inspection and Repair

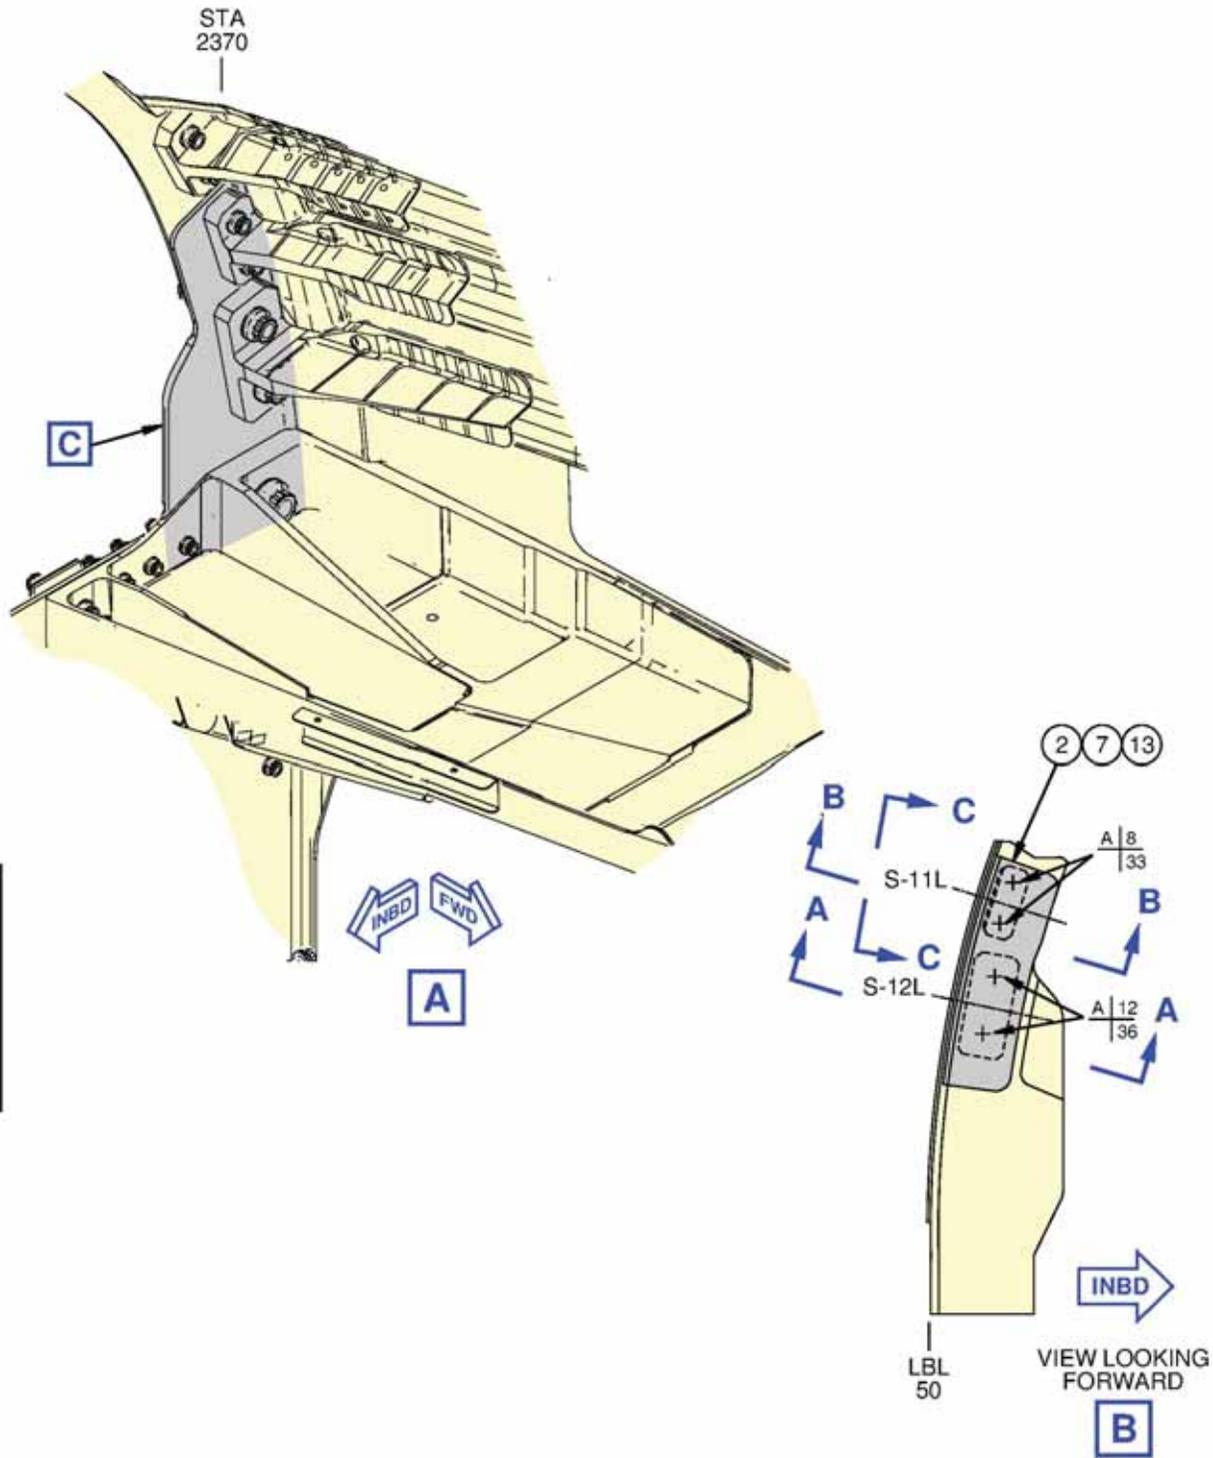
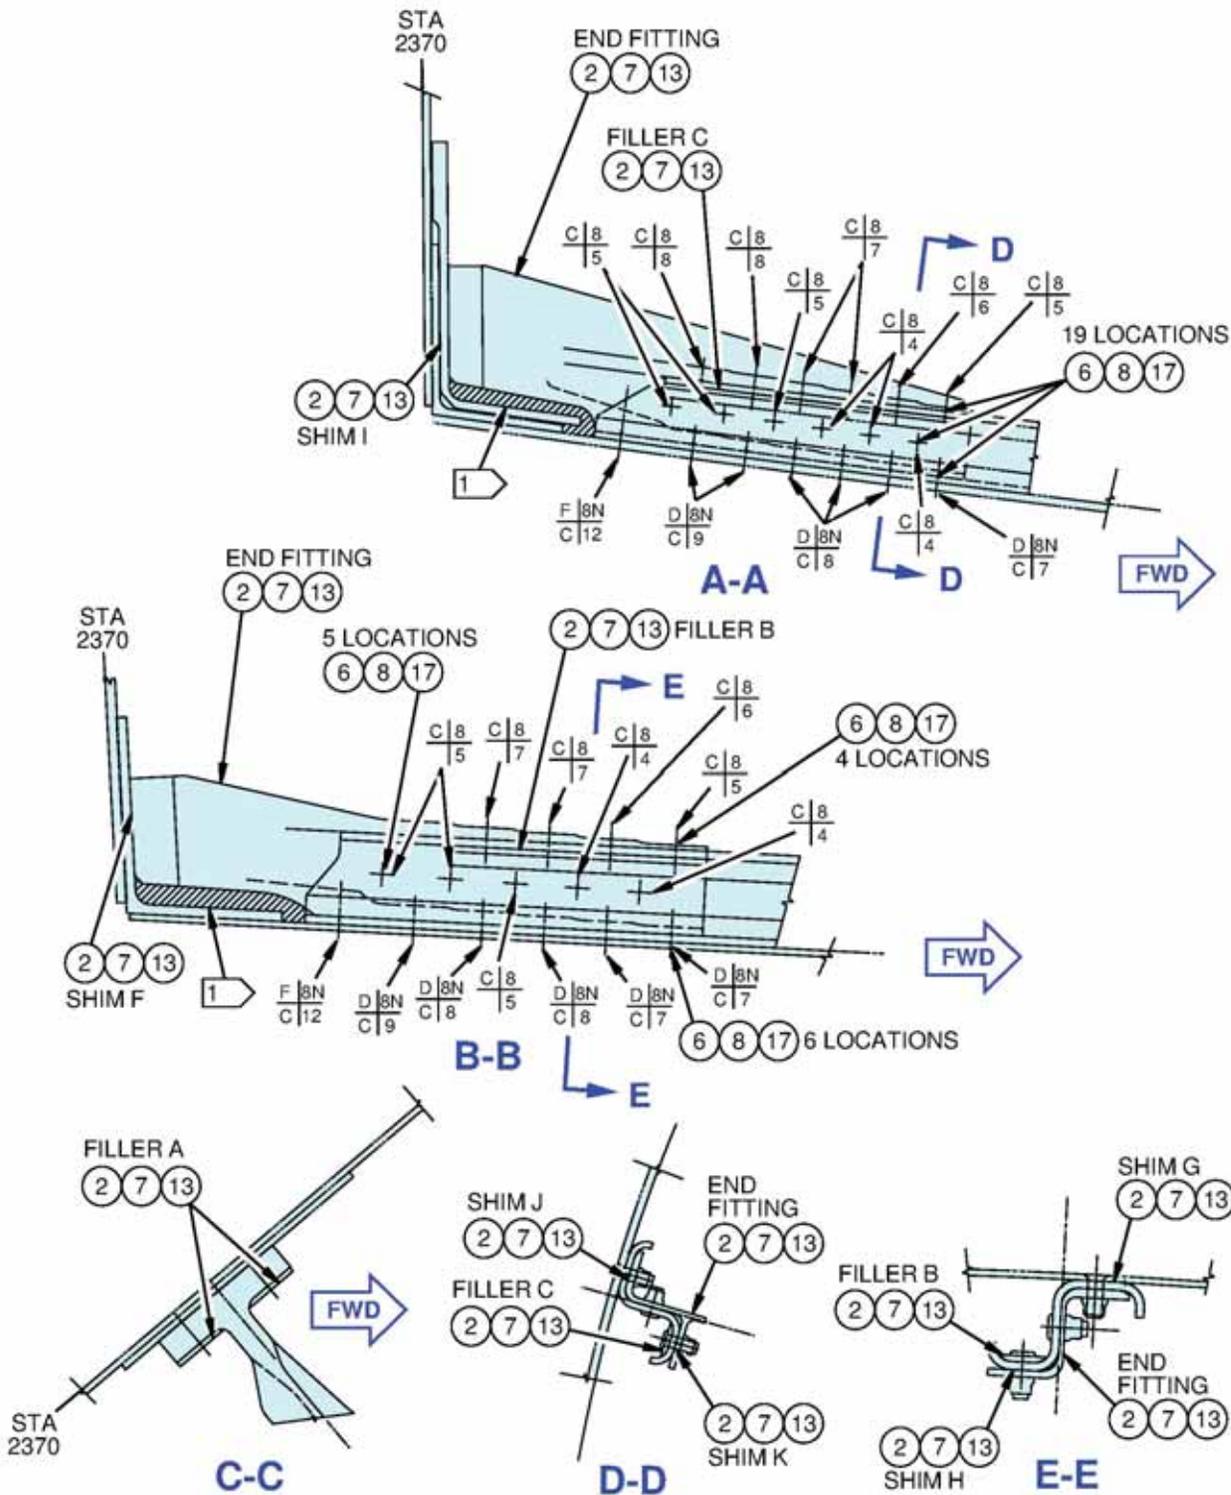
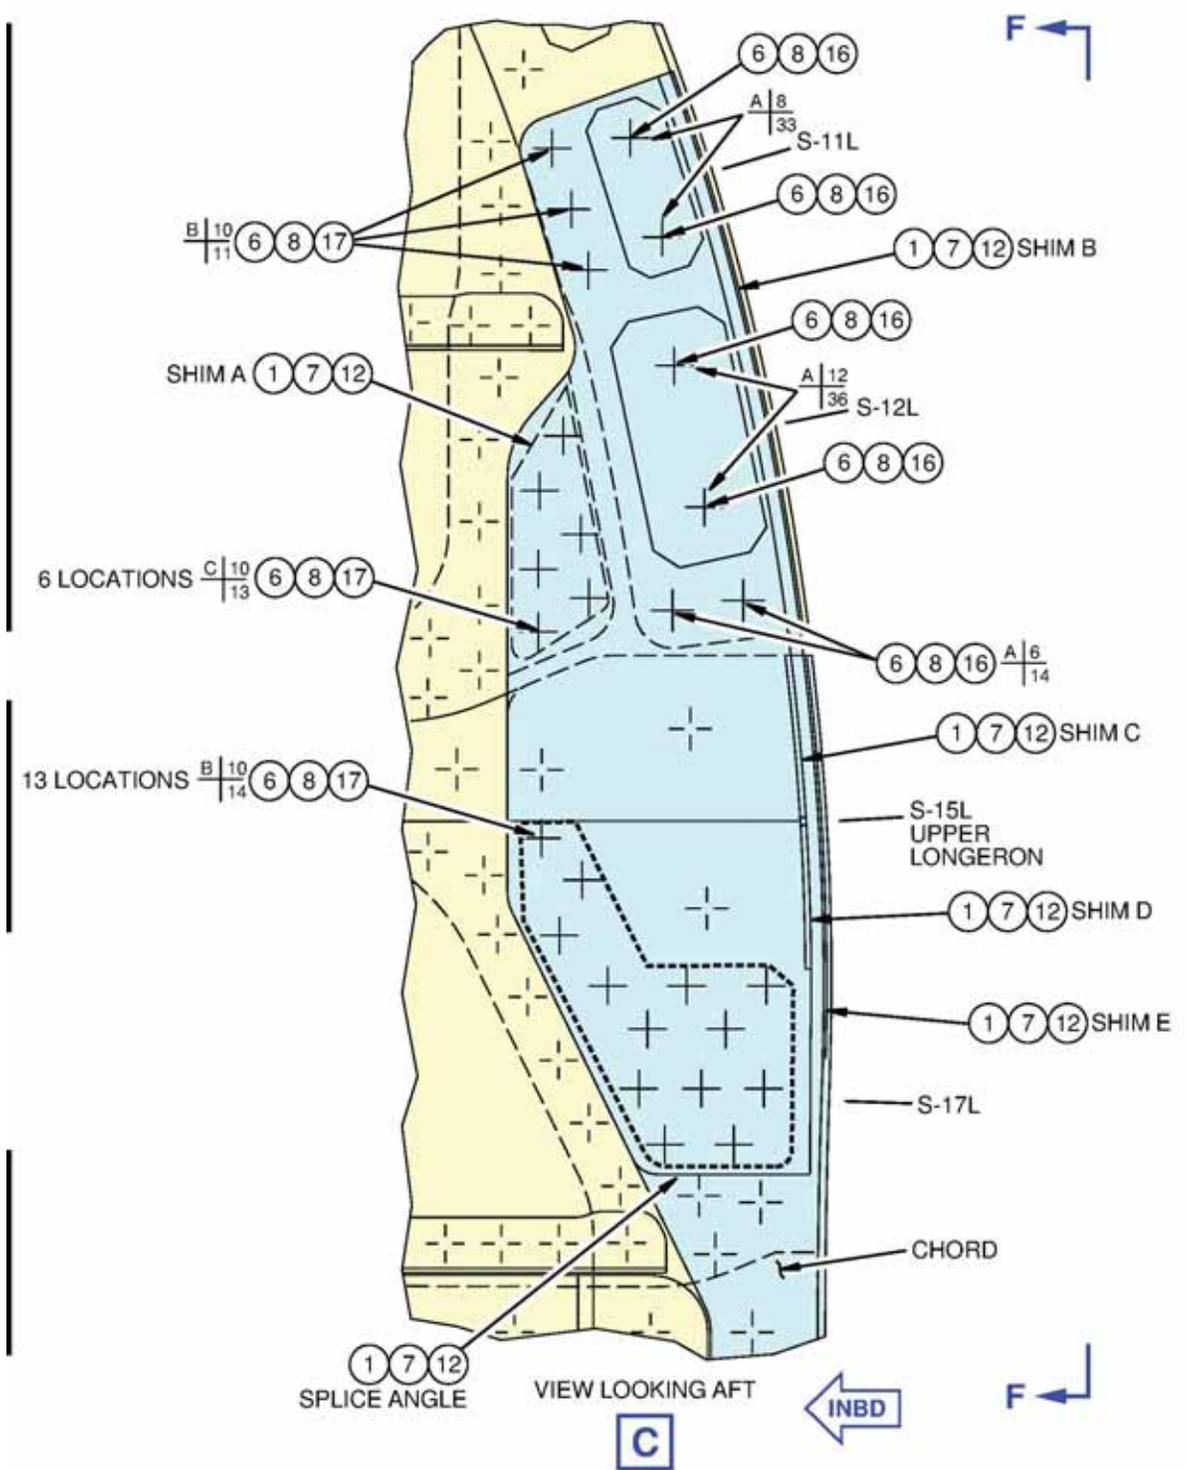
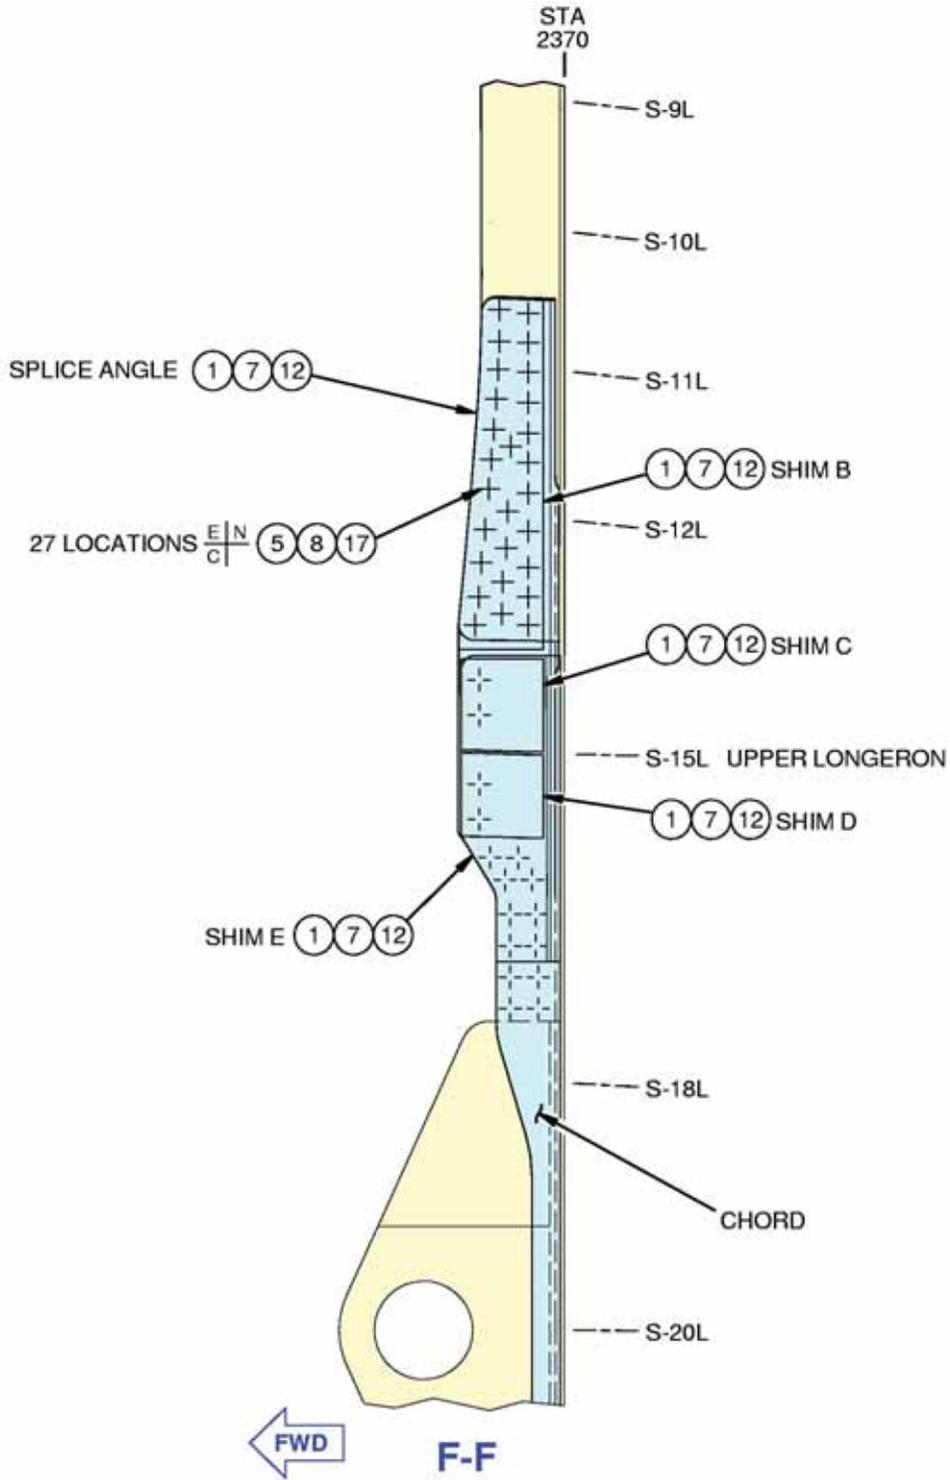
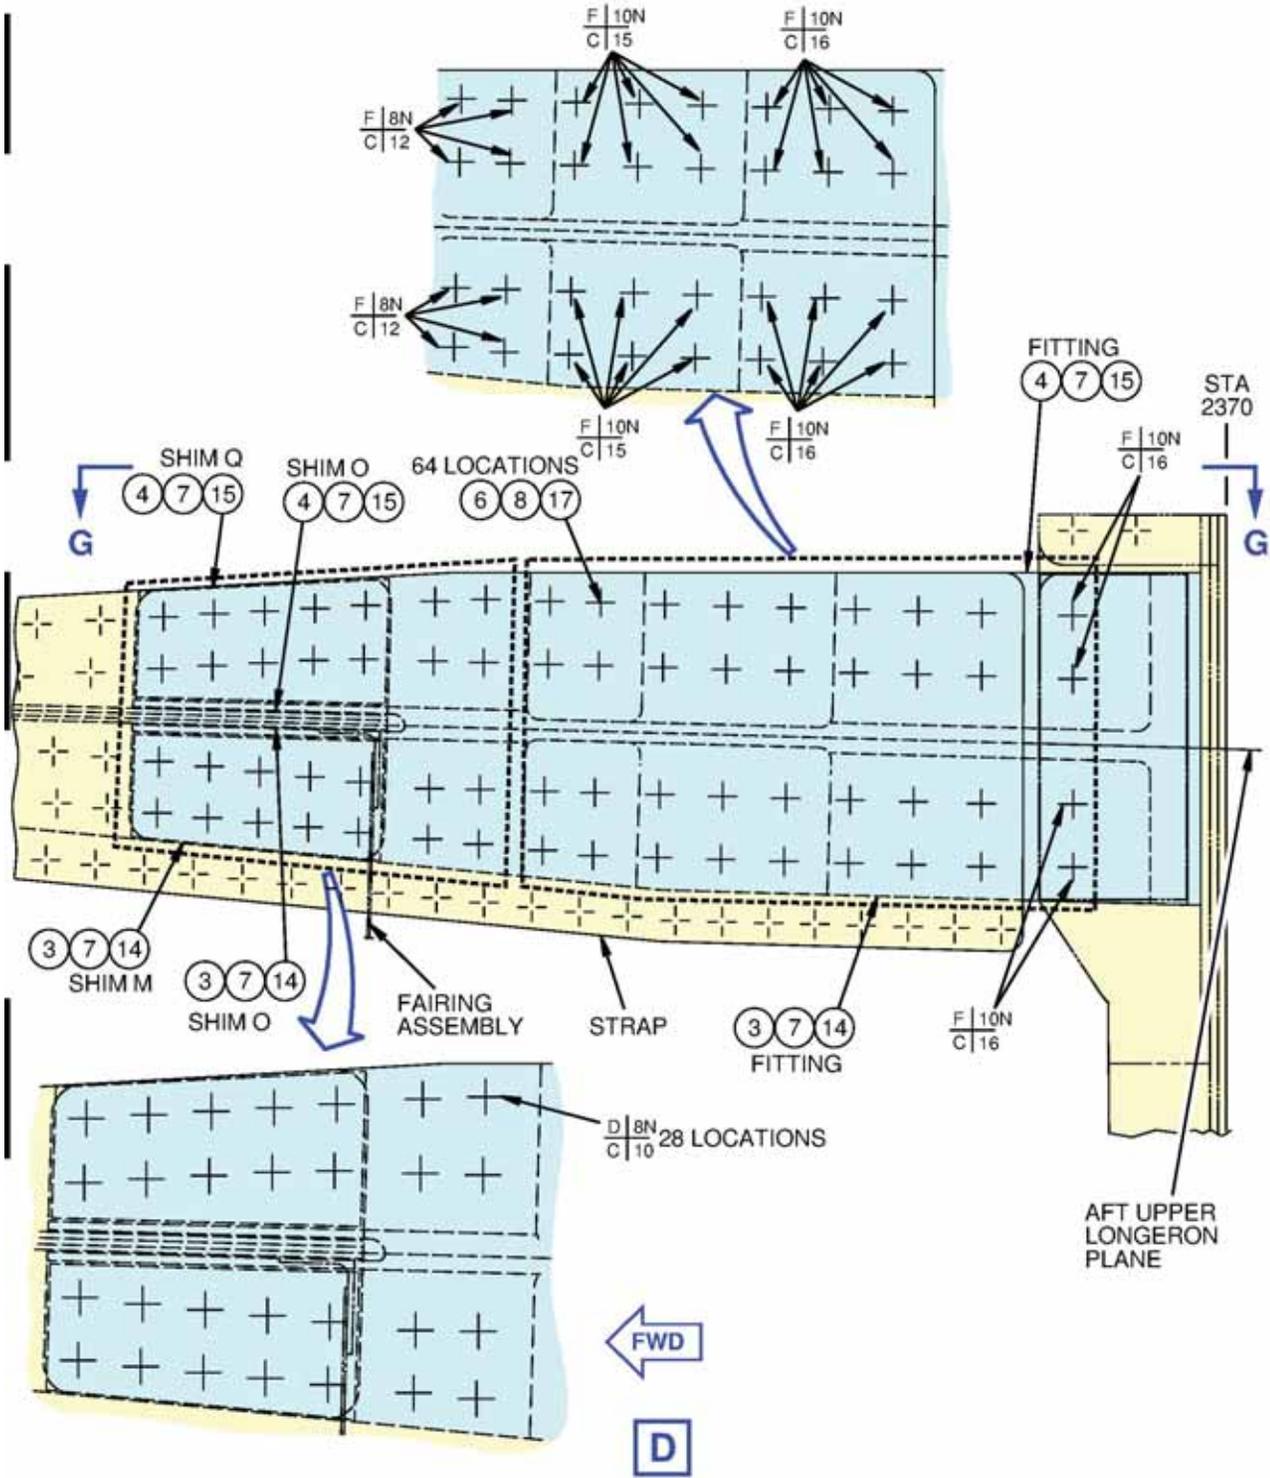
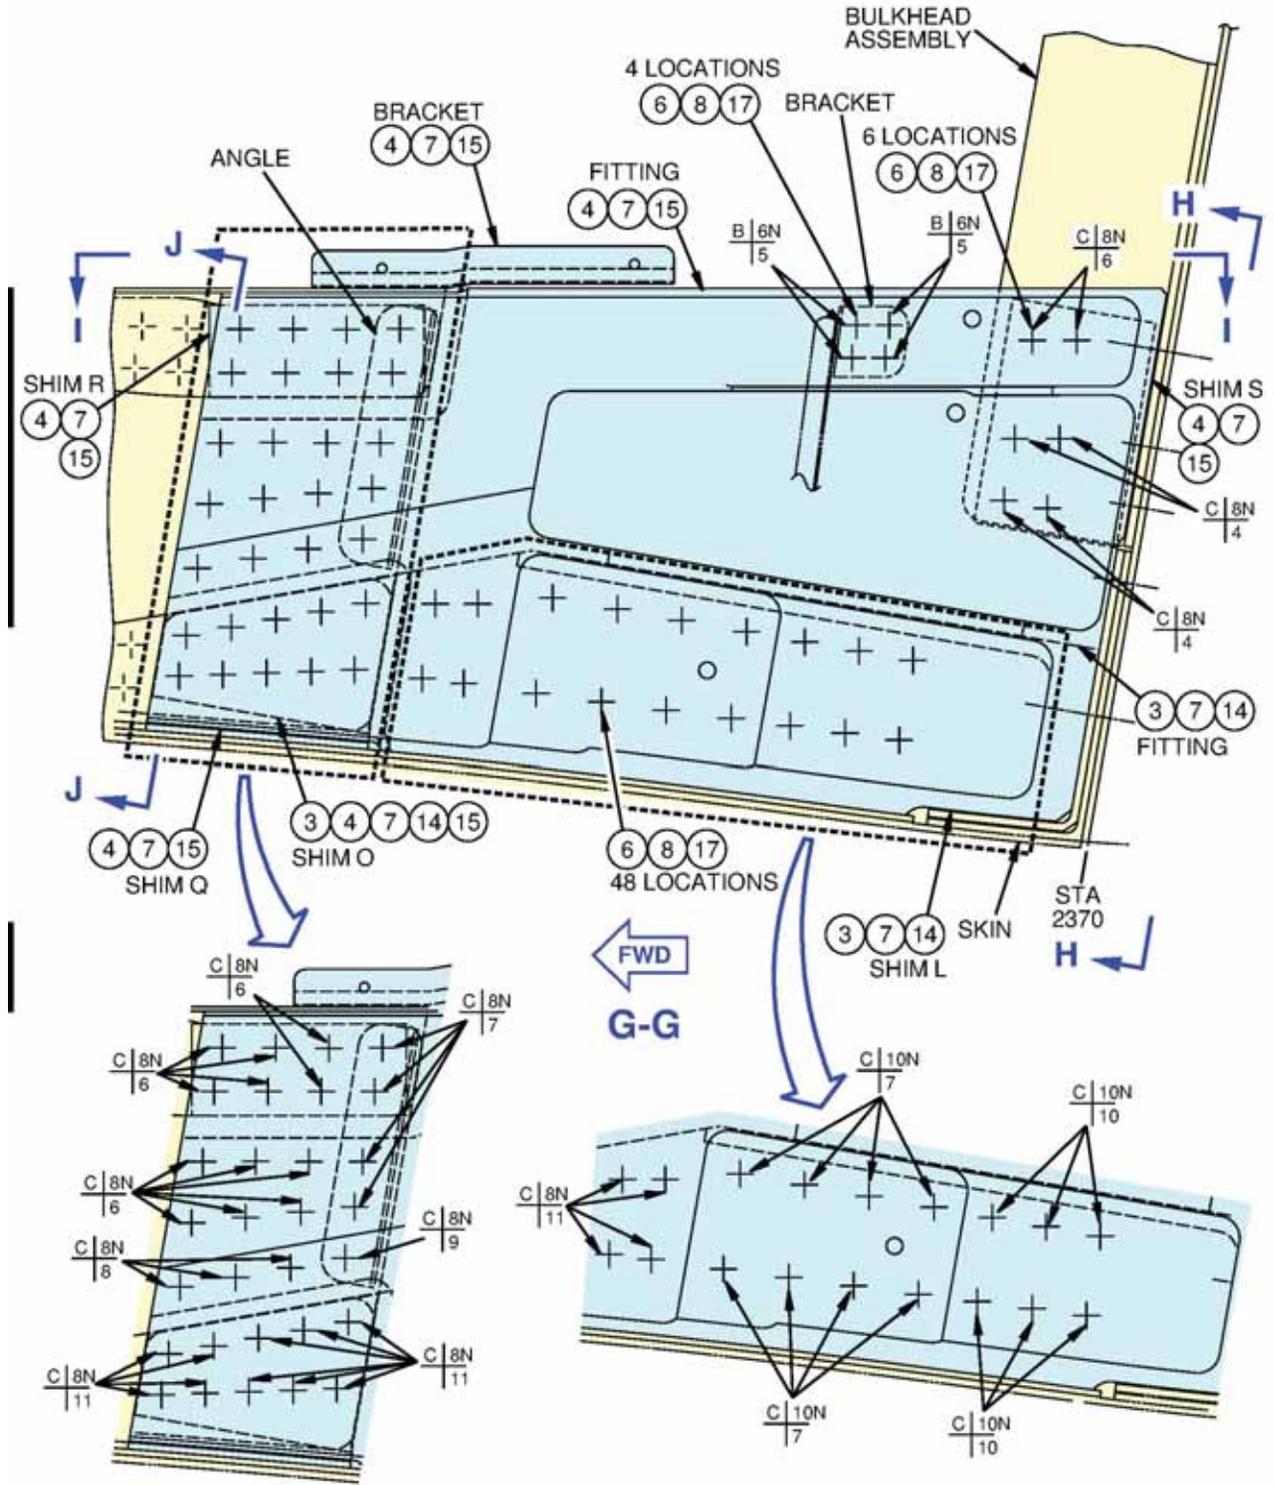
FIGURE 15: LEFT SIDE - STA 2370 PIVOT BULKHEAD FORWARD CHORD - REPAIR
(SHEET 1 OF 22)

Step	Task	Name	Identification	Qty	More Data
9	Cut	CHORD	148W7102-()	1	the damaged edge in accordance with 777-200 SRM 51-10-02 or 777-300 SRM 51-10-02, as applicable. Minimum material removed equals the length of the longest detected crack, and not to exceed 0.160 inch.
	Deburr	CHORD	148W7102-()	1	
	Inspect	CHORD	148W7102-()	1	Do a surface High Frequency Eddy Current (HFEC) inspection of the cut edge, to make sure any crack was removed, in accordance with 777 NDT Manual Part 6, 51-00-01. (a)
	Cut	CHORD	148W7102-()	1	0.04 inch insurance cut. Maximum edge trim out is 0.200 inch. Blend the edge to a minimum radius of 1.50 inch. Maintain a shoulder slope of runout of minimum 1.0 inch.
	Deburr	CHORD	148W7102-()	1	Deburr the cut edge. The surface roughness of the cut edge is 63 Ra or better.

Step	Task	Name	Identification	Qty	More Data
10	Shot Peen	CHORD	148W7102-()	1	The indicated in-board and outboard surface of the chord. Shot intensity is 0.010A, shot size is 330, and coverage is 100%. Refer to SOPM 20-10-03, Self-Contained Shot Peening, as an accepted procedure.
11	Apply	CHEMICAL CONVERSION COATING	-	-	to the cut surface, in accordance with 777-200 SRM 51-20-01 or 777-300 SRM 51-20-01, as applicable.
	Apply	PRIMER	BMS 10-11, TYPE I	-	two coats, on the cut surface. Refer to SOPM 20-41-02 as an accepted procedure.
12	Install (New)	SPLICE ANGLE	148W2204-5	1	modified in accordance with FIGURE 13. (f)
	Install (New)	SHIM LAMINATED	148W7143-11	1	SHIM A (e) (f)
	Install (New)	SHIM LAMINATED	148W7143-13	1	SHIM B (e) (f)
	Install (New)	SHIM LAMINATED	148W7143-7	1	SHIM C (e) (f)
	Install (New)	SHIM LAMINATED	148W7143-6	1	SHIM D (e) (f)
	Install (New)	SHIM LAMINATED	148W7143-5	1	SHIM E (e) (f)

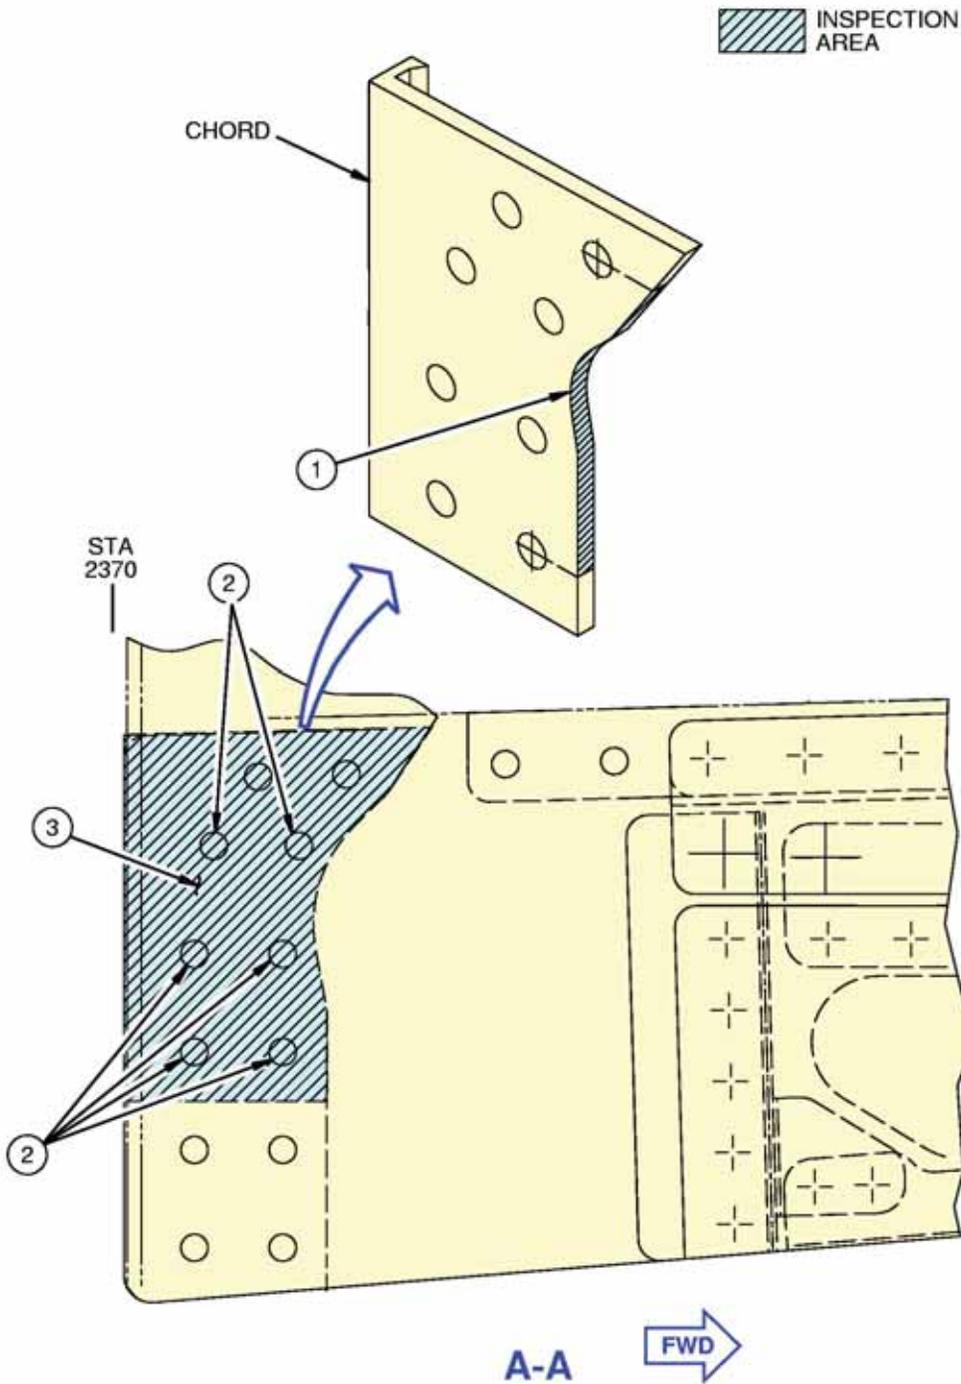
FIGURE 20: RIGHT SIDE - STA 2370 PIVOT BULKHEAD FORWARD CHORD - POST-REPAIR DET AND HFEC INSPECTION (SHEET 2 OF 3)

Step	Task	Name	Identification	Qty	More Data
1	Inspect	CHORD - FORWARD, PIVOT BULKHEAD, MID	148W7102-()	1	Do a surface High Frequency Eddy Current (HFEC) inspection for any crack, in accordance with 777 NDT Manual Part 6, 51-00-01.
2	Inspect	CHORD - FORWARD, PIVOT BULKHEAD, MID	148W7102-()	1	Do an open hole HFEC inspection for any crack, in accordance with 777 NDT Manual Part 6, 51-00-02.
3	Inspect	CHORD - FORWARD, PIVOT BULKHEAD, MID	148W7102-()	1	Do a DET for any crack.

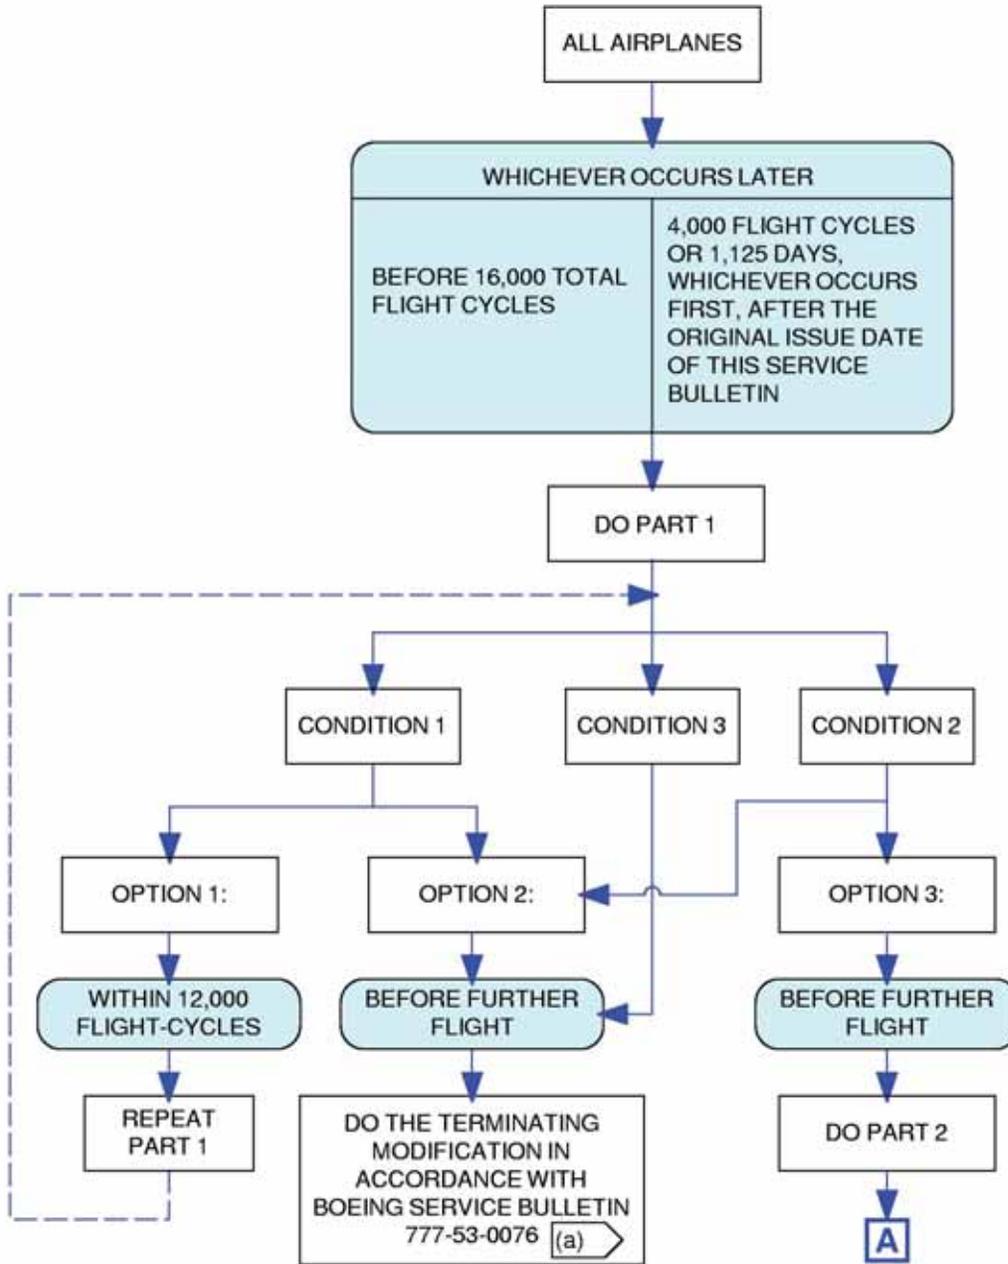
LOGIC DIAGRAM FOR PARAGRAPH 1.E. COMPLIANCE: TABLE 1: DETAILED AND HFEC INSPECTION OF THE STA 2370 PIVOT BULKHEAD FORWARD CHORD

Title	Description
PART 1	STATION 2370 PIVOT BULKHEAD FORWARD CHORD - DET AND HFEC INSPECTION
PART 2	STATION 2370 PIVOT BULKHEAD FORWARD CHORD - SMALL CRACK REPAIR
PART 3	STATION 2370 PIVOT BULKHEAD FORWARD CHORD - POST-REPAIR DET AND HFEC INSPECTION
CONDITION 1	NO FORWARD CHORD CRACK IS FOUND
CONDITION 2	ANY FORWARD CHORD CRACK IS FOUND, AND NO CRACK FOUND IS GREATER THAN 0.160 INCH
CONDITION 3	ANY FORWARD CHORD CRACK FOUND IS GREATER THAN 0.160 INCH
CONDITION 6	NO FORWARD CHORD UPPER LOCATION OR ADJACENT STRUCTURE CRACK IS FOUND
CONDITION 7	ANY FORWARD CHORD UPPER LOCATION OR ADJACENT STRUCTURE CRACK IS FOUND

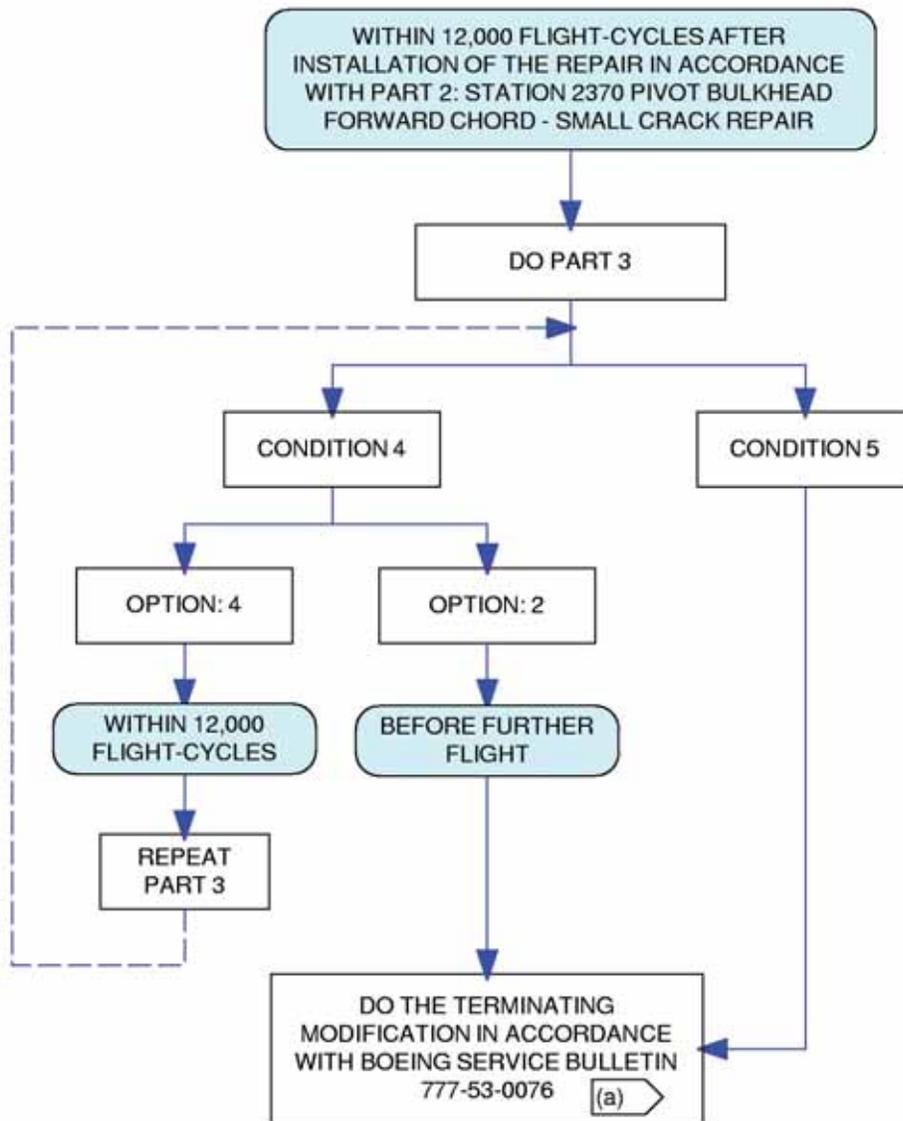
LOGIC DIAGRAM FOR PARAGRAPH 1.E. COMPLIANCE: TABLE 2: POST REPAIR DETAILED AND HFEC INSPECTION OF THE STA 2370 PIVOT BULKHEAD FORWARD CHORD

Title	Description
PART 3	STATION 2370 PIVOT BULKHEAD FORWARD CHORD - POST-REPAIR DET AND HFEC INSPECTION
CONDITION 4	NO FORWARD CHORD CRACK IS FOUND DURING POST-REPAIR INSPECTIONS
CONDITION 5	ANY FORWARD CHORD CRACK IS FOUND DURING POST-REPAIR INSPECTIONS
